# Economic Benefits of Code Compliant Non-Structural Elements in New Buildings

Ministry of Business, Innovation & Employment

Date: 20 March 2017  
Reference: 6-DP292.01  
Status: Final

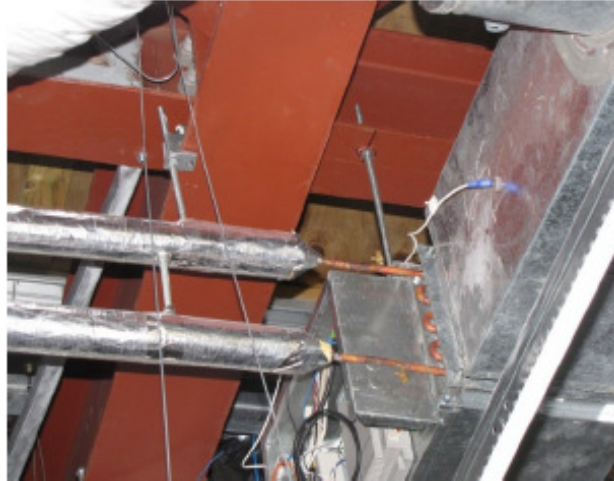
- Equipment suspended within ceiling voids was, in some cases, found to not comply with Clause 5.2.2 of NZS 4219 which requires flexible connections when services and ceilings are not supported together. Examples of non-compliance included unrestrained pipe branches connecting to unrestrained ventilation equipment, without a flexible connection.
- Mechanical equipment weighing in excess of 10kg was found to be unrestrained. This does not comply with Clause 5.9 of NZS 4219.

**Figure 5: Lack of flexible connections to mechanical plant**

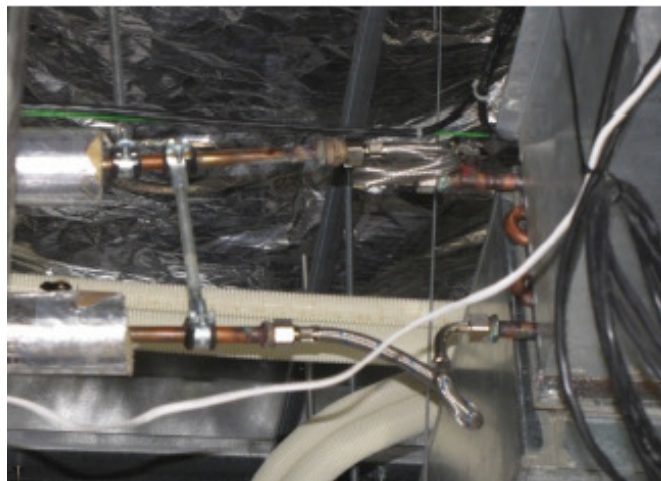
**Figure 6: Use of flexible connections on mechanical plant to achieve compliant installation**

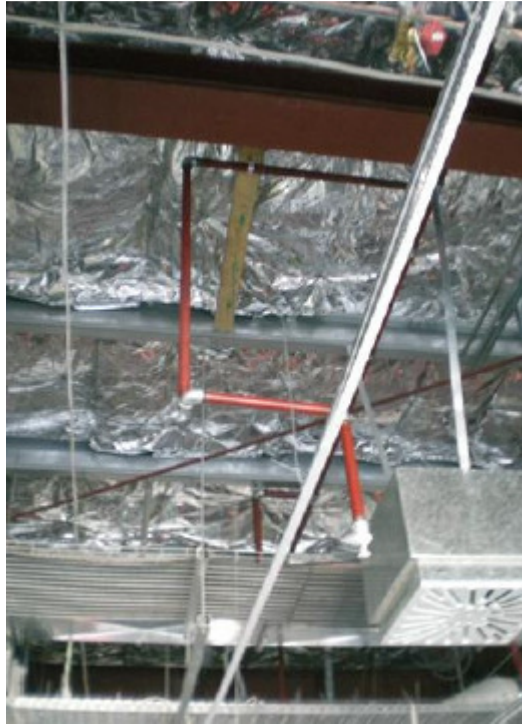
- Ventilation grilles and diffusers weighing in excess of 10kg were observed to be unrestrained. This does not comply with Clause 5.9 of NZS 4219 and leaves the equipment at significant risk of failure. The economic cost of failure of the diffuser needs to be considered in the context of what is around the diffuser/grille. The damage and associated repair costs is likely to be more than just the diffuser/grille itself, as the effect of this equipment swinging around is likely to cause damage and require repairs to nearby pipework, connections, equipment, ceiling hangers and other near-by services, and may also cause suspended ceilings and other equipment to fall and render the area unusable and cause interruption to business operations.

**Figure 7: Unrestrained diffusers**

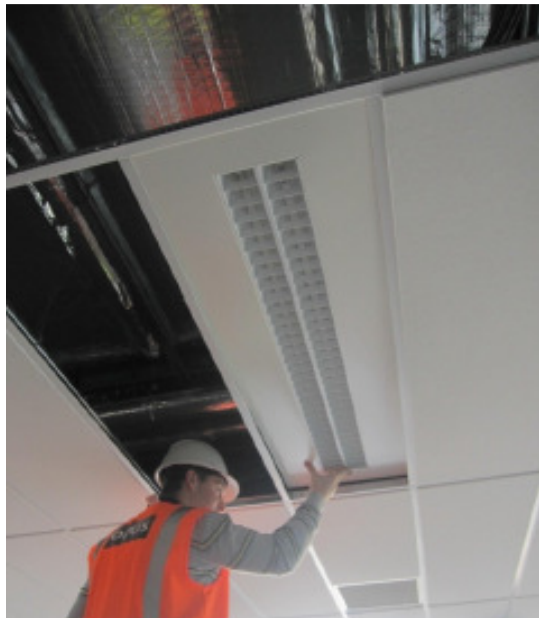
- Luminaires dislodged from ceiling grids
  - Installations were observed where recessed luminaires did not appear to be positively fixed to the ceiling grid and therefore failed to comply with Clause 5.14 of NZS 4219. The weight of recessed luminaires can be significant and if they fall they risk injuring occupants below and causing business interruption.

**Figure 8: Unsecured recessed luminaires**

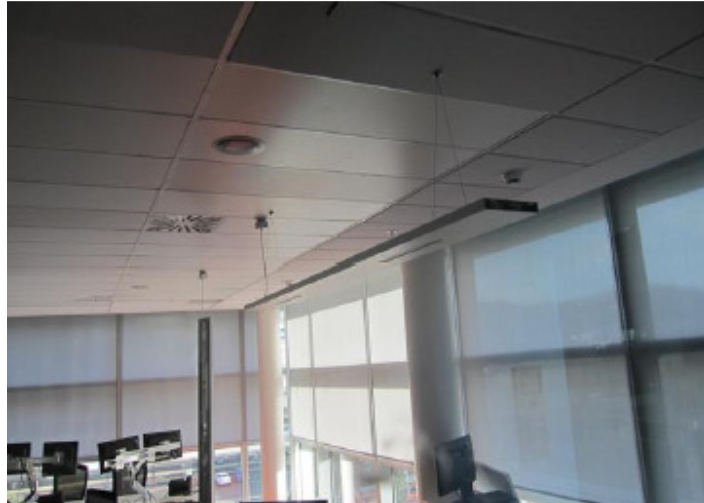
- Freely suspended luminaires suspended on stay wires from ceiling tiles were observed. The use of vertical stay wires does not meet the requirements of NZS 4219 - Clause 5.14 as it allows the luminaire to move in an earthquake and impact with the building or other equipment. In some instances the support wires broke causing the luminaires to fall.

Figure 9: Typical suspended luminaire

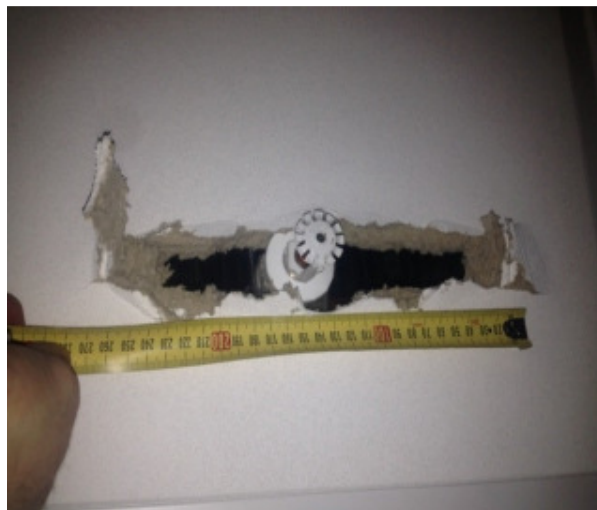
- Direct connection of sprinkler droppers to fixed cable tray and ductwork supports did not meet the code (NZS 4541) requirement that the sprinkler pipes and joints will not experience undue deflection. In particular failure was observed when the dropper arm was connected to heavily loaded unrestrained cable tray. The costs of consequential damage and business interruption due to failure of the sprinkler head is substantial with the potential for water damage that drains to multiple floors.

Figure 10: Relative movement of sprinkler and ceiling

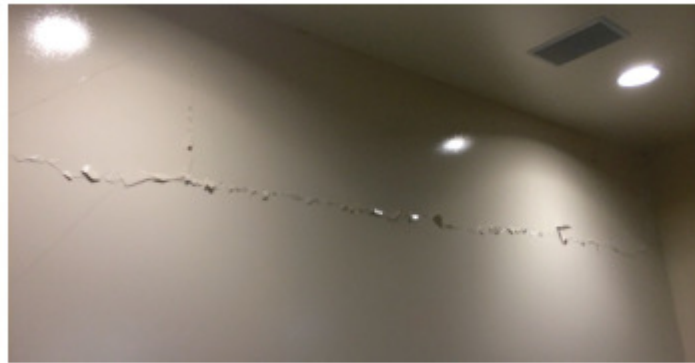
**Figure 12: Cracked gypsum board wall in hospital**

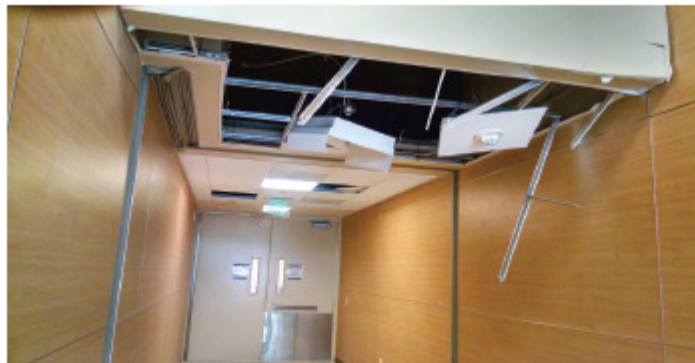
**Figure 13: Ceiling damage in hospital corridor link**

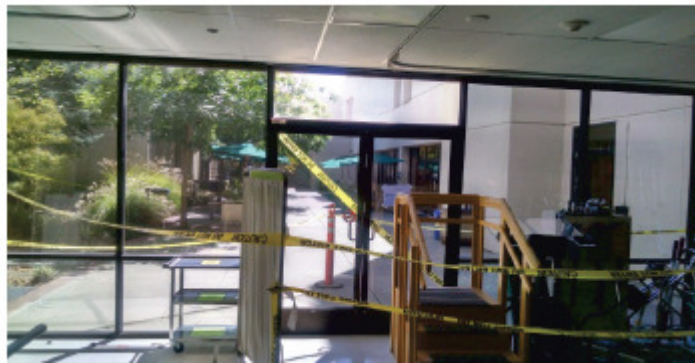
**Figure 14: Damage to glazing leading to entrance being posted as "restricted use"**

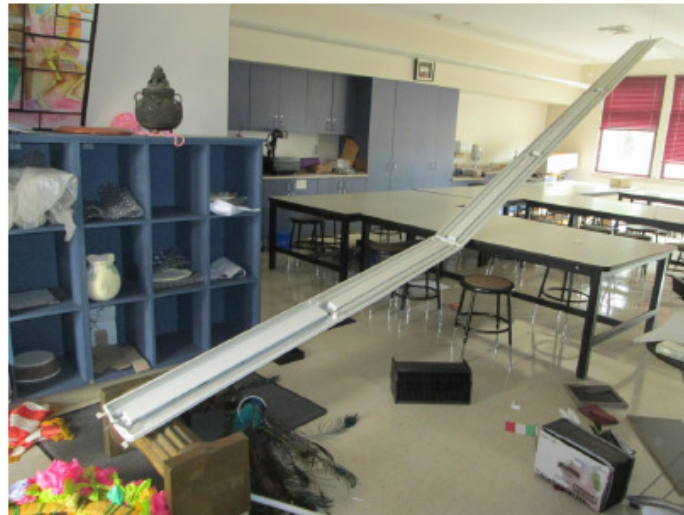
**Figure 15: Damaged light fixtures - commonly observed in school facilities**
