EXPERT PANEL REPORT

Structural Performance of Christchurch CBD Buildings in the 22 February 2011 Aftershock

February 2012

Report of an Expert Panel appointed by the New Zealand Department of Building and Housing

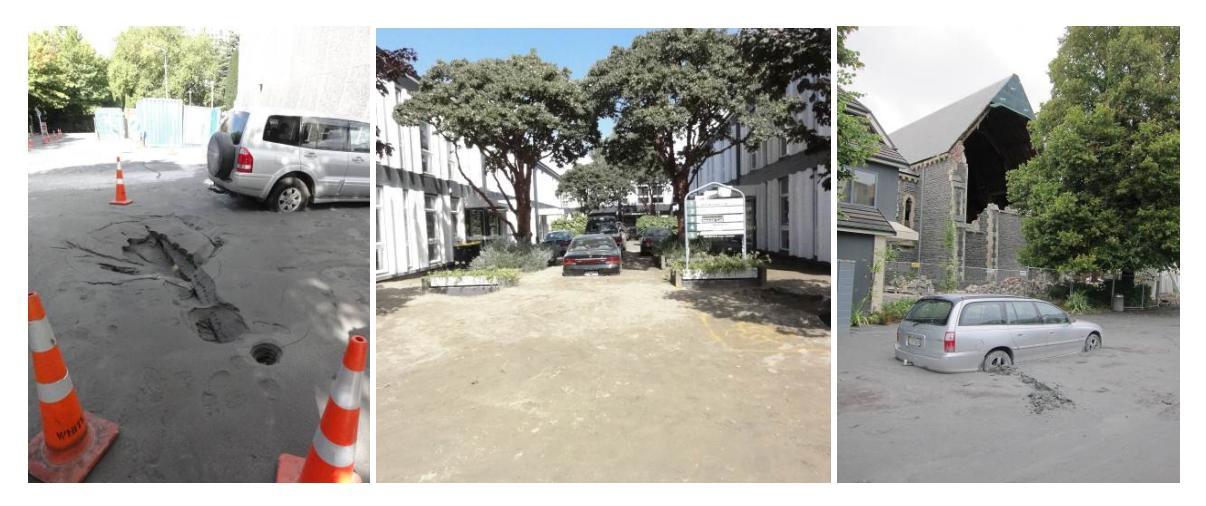
Figure 19: Liquefaction damage within the Christchurch CBD: a) Kilmore Street ; b) Armagh Street ; c) Manchester Street

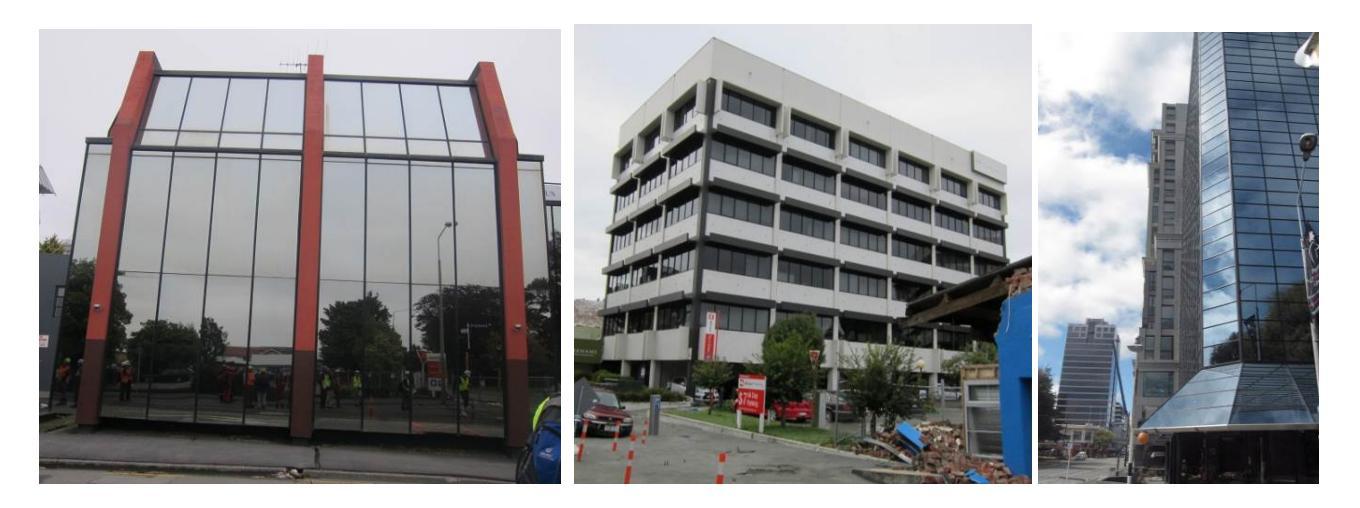
Figure 20: Liquefaction induced differential settlement resulting in significant tilting of mid- to high-rise buildings of various foundation and soil details: a) Four-storey with shallow foundation; b) Six-storey with piled foundation; c) Three high-rise buildings with substantial differential settlement and tilting.

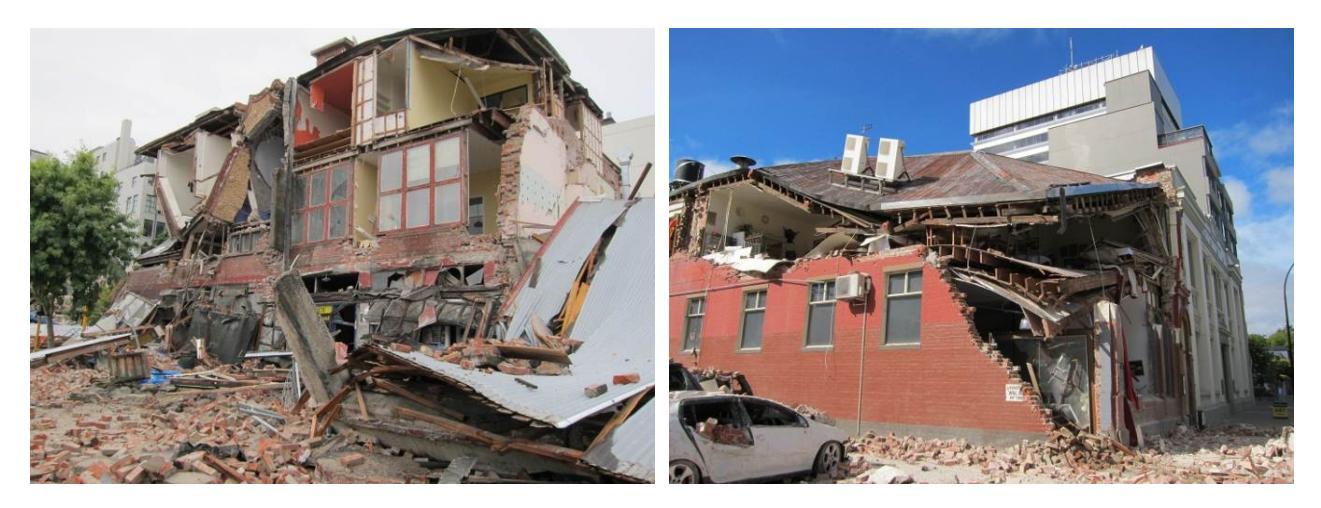
Figure 29: Unreinforced masonry buildings collapse/damage patterns: Mixed of in-plane and out-of-plane failure modes

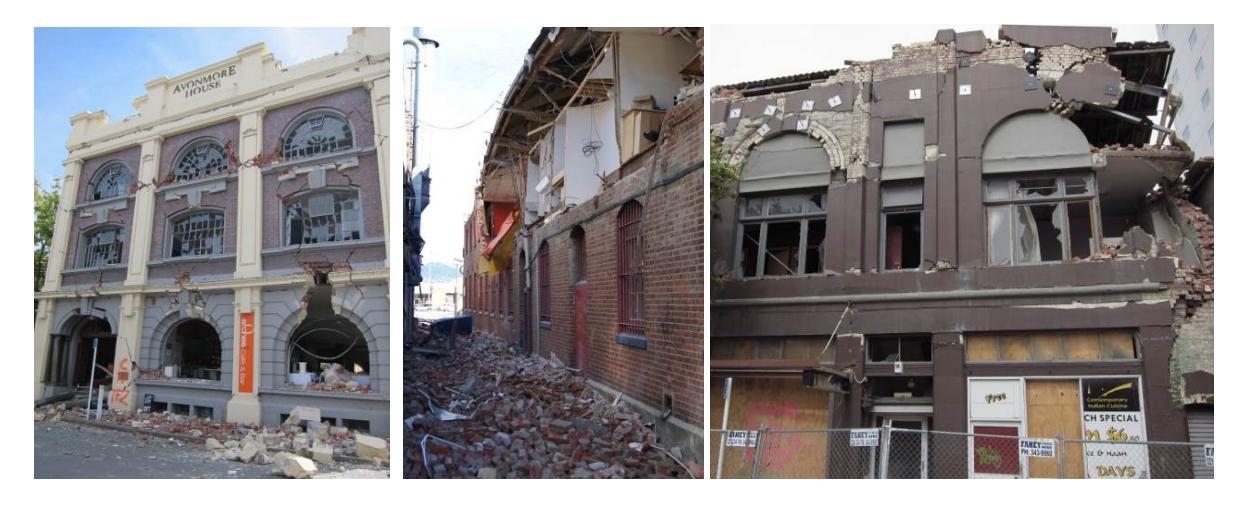
Figure 30: Unreinforced masonry buildings collapse/damage patterns: Mixed of in-plane and out-of-plane failure modes

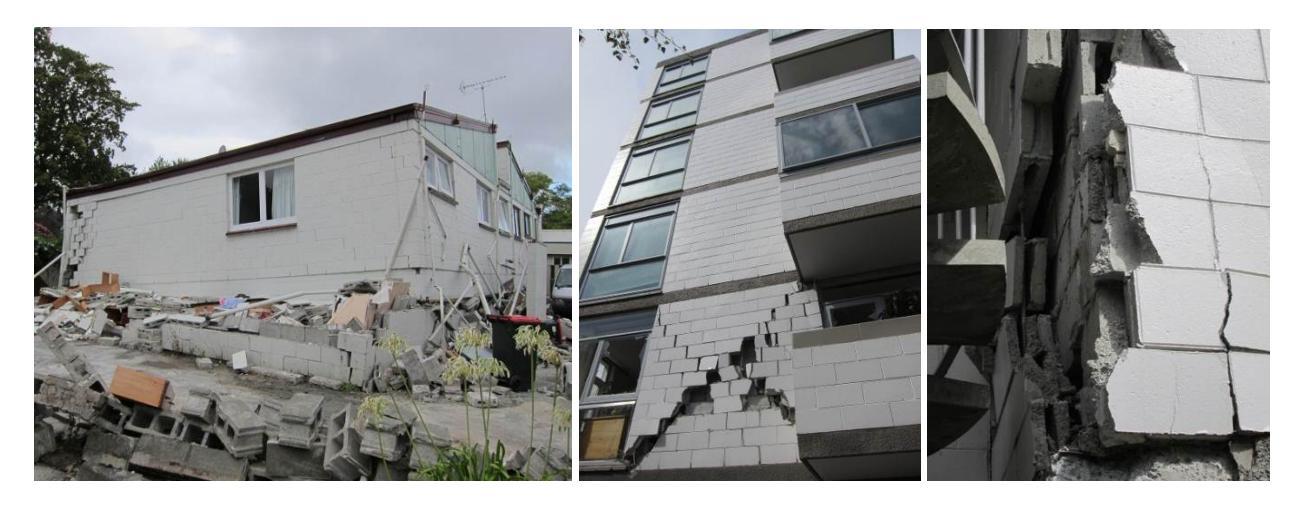
Figure 33: Reinforced concrete masonry buildings collapse/damage patterns: a) two-storey residential building with complete soft-storey collapse of the first floor; b-c) Shear failure of the 2nd floor RCM walls of a six-storey residential apartment built in the 1960s

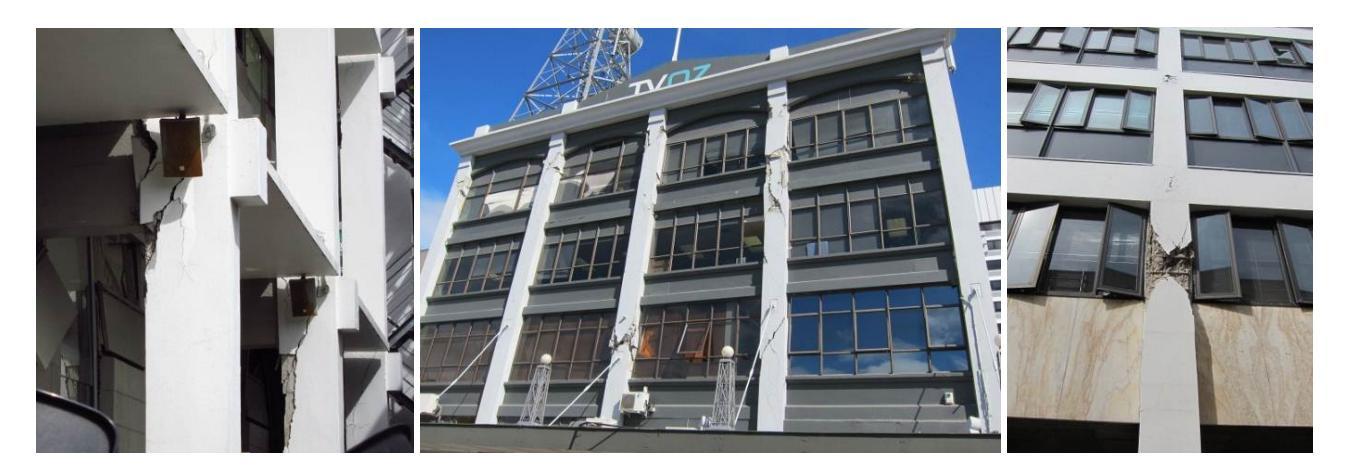
Figure 35: Pre-1970s reinforced concrete moment-resisting frame buildings collapse/damage patterns

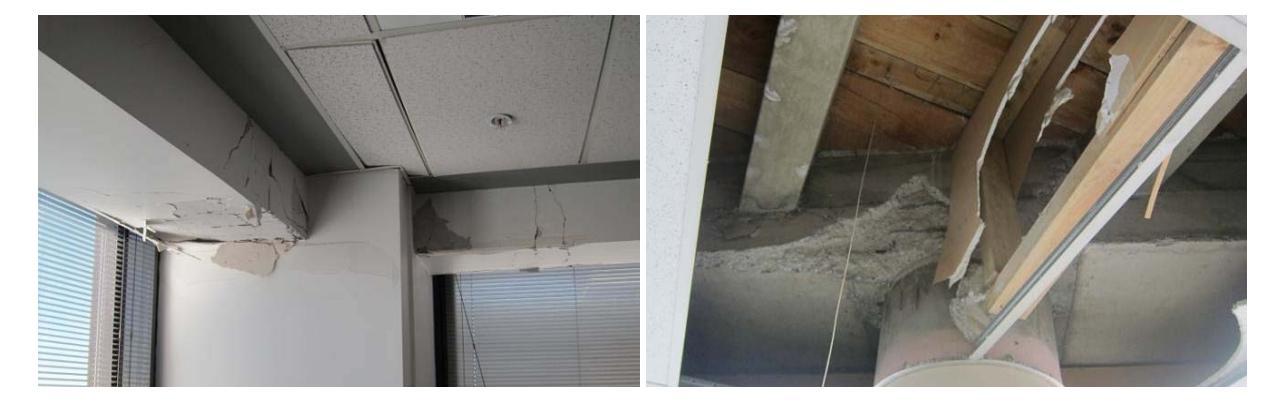
Figure 36: Post-1970s reinforced concrete moment-resisting frame buildings collapse/damage patterns: a) Twoway plastic hinging on 5th floor of a 22-storey office tower; b) 2nd floor beam-column connection in a fivestorey office building

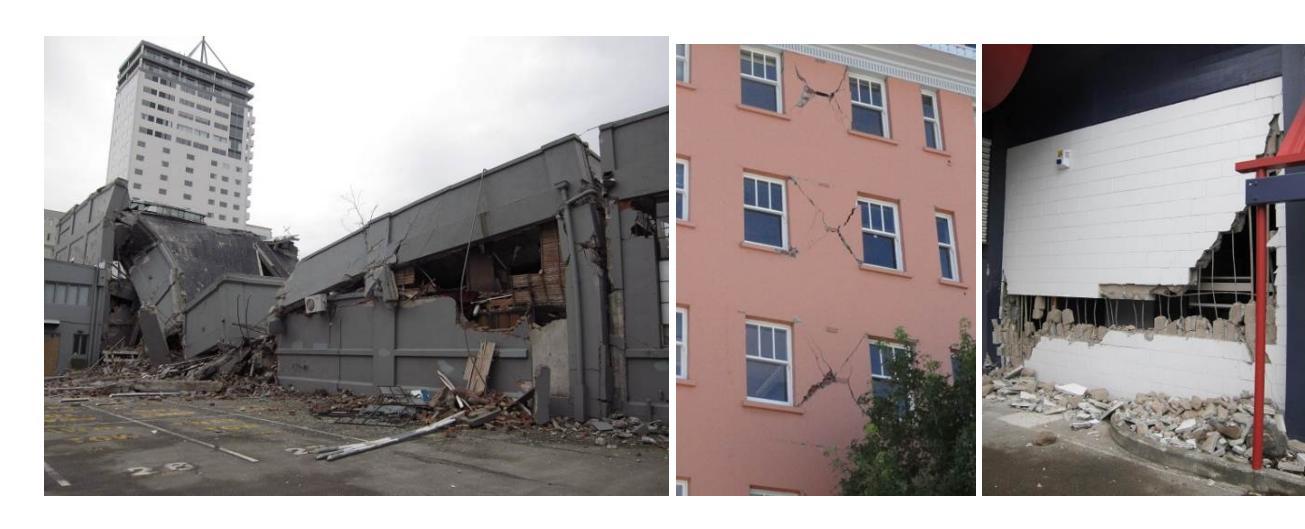
Figure 38: Reinforced concrete frame buildings collapse/damage patterns: a) 1930s three-storey RC frame with masonry infill collapsed after the 13th June M_w 6.2 aftershock; b) 1935 seven-storey RC frame with masonry infill and veneers; c) 1970s two-storey RC frame with reinforced concrete masonry blocks

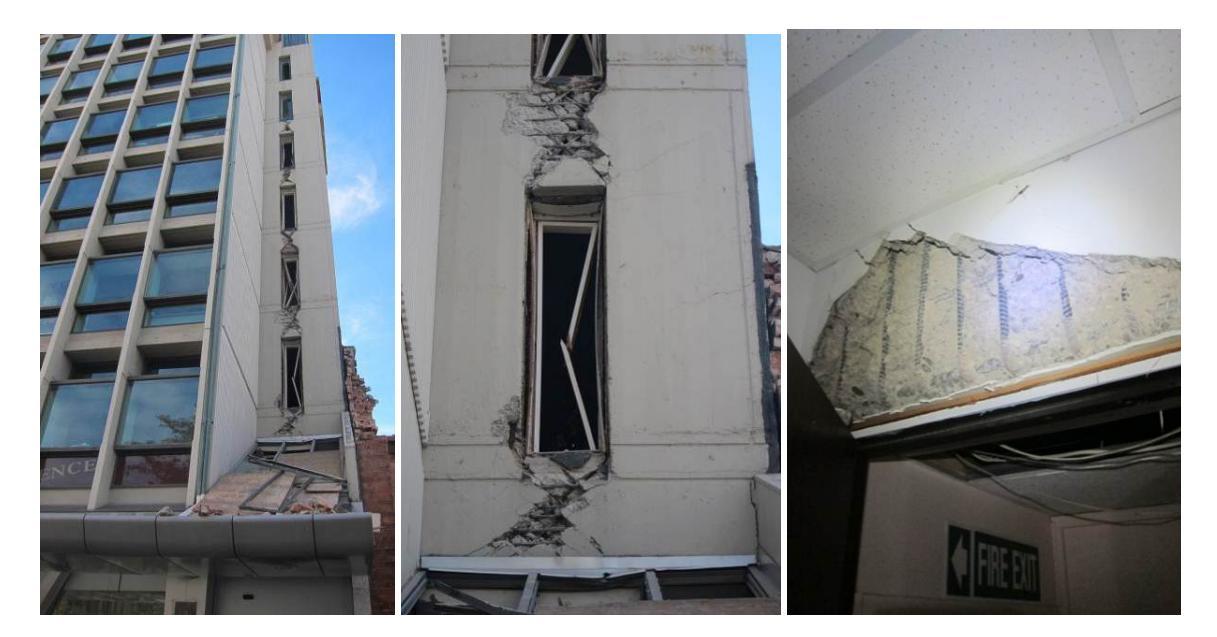
Figure 40: Pre-1970s reinforced concrete structural wall buildings collapse/damage patterns: a-b) Seven-storey 1960s coupled-RC walls building with significant damage on the coupling beams. Plain bars and diagonal reinforcements were used on the coupling beams; c) Six-storey 1950s RC walls building with moderate damage to the coupling beams

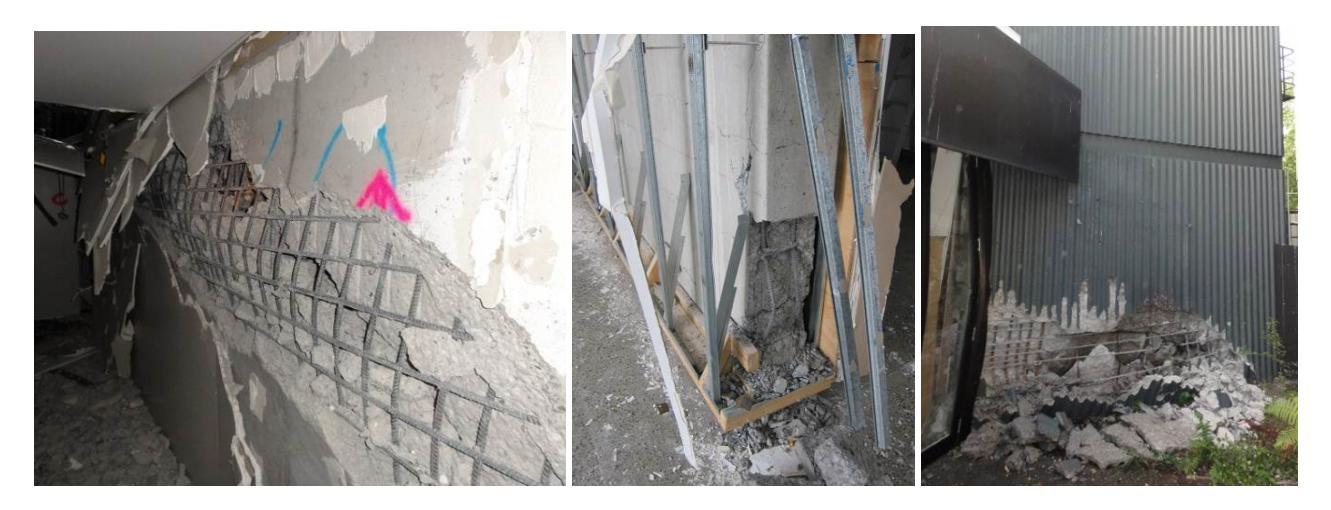
Figure 41: Post-1970s reinforced concrete structural wall buildings collapse/damage patterns: a) Nine-storey residential apartment built in 2000-2010 with severe shear failure of the long slender wall (photo courtesy of Ken Elwood); b) 14-storey residential apartment built in 2007 with buckling of the boundary reinforcements; c) Seven-storey 1980s office block with significant compression failure of the V-shaped RC shear wall

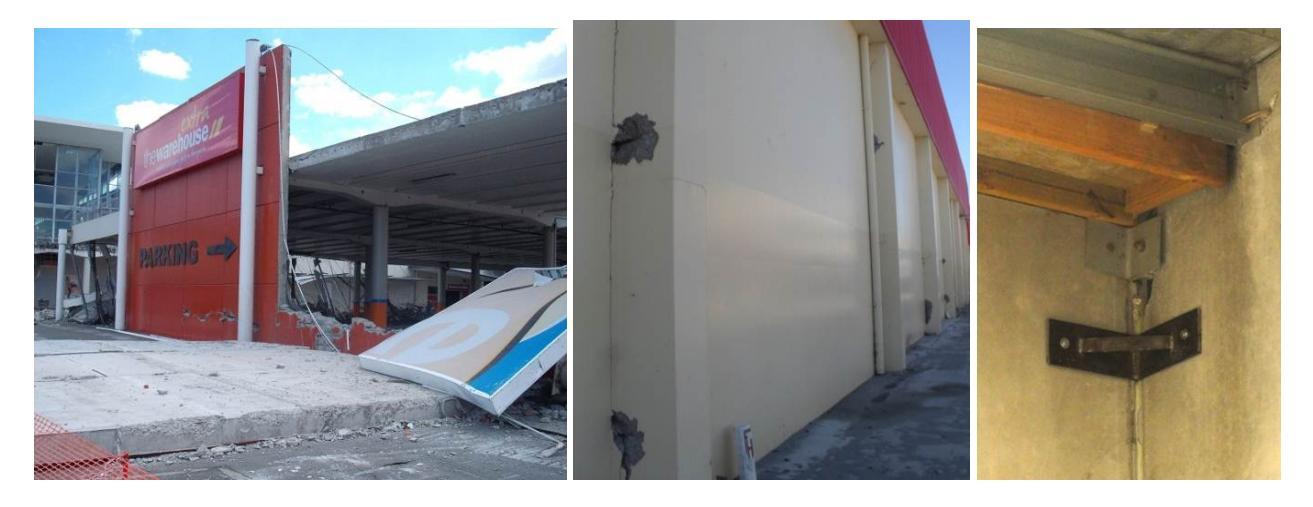
Figure 43: Tilt-up concrete wall buildings collapse/damage patterns: a) Failure of the spliced-connection of the tilt-up panel walls (photo courtesy of John Marshall); b) Tilt-up panels with encased steel portal frame; c) Steel angle connection damaged in the 4th Sept earthquake, repaired with a supplementary bolted steel angle

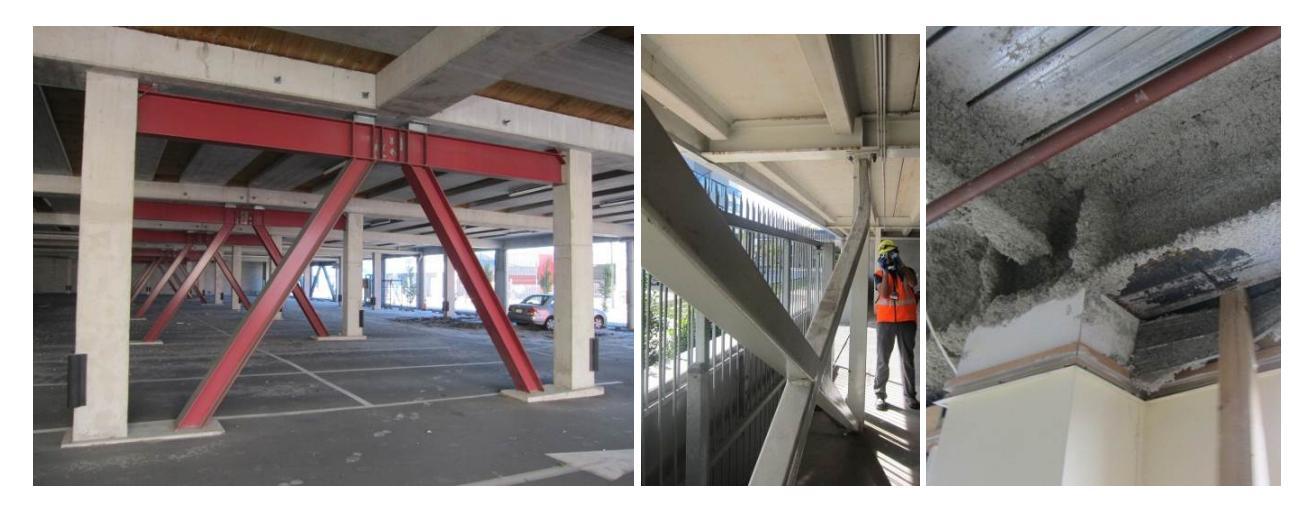
Figure 45: Steel frame and steel-braced buildings. collapse/damage patterns: a) Yielding and fracture of the shear-link of eccentric-braced frame with composite gravity frame; b) buckling and fracture of diagonal steel braces; c) Yield lines on steel-frame

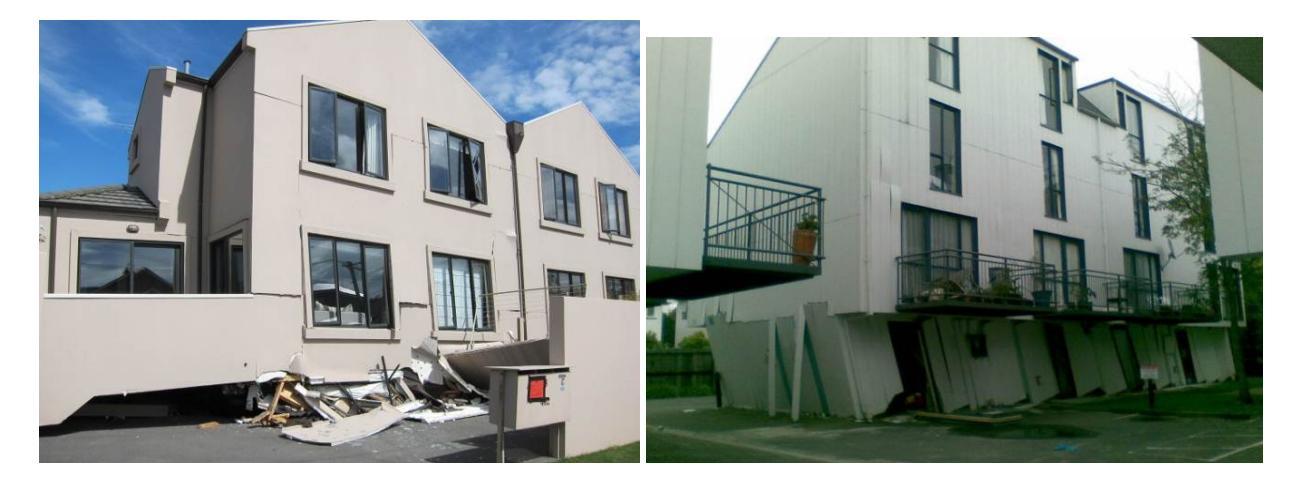
Figure 47: Timber buildings collapse/damage patterns: a) Soft-storey collapse of a relatively modern residential apartment; b) Soft-storey collapse of a four-storey residential apartment (Photo courtesy of Julian Ramsay)

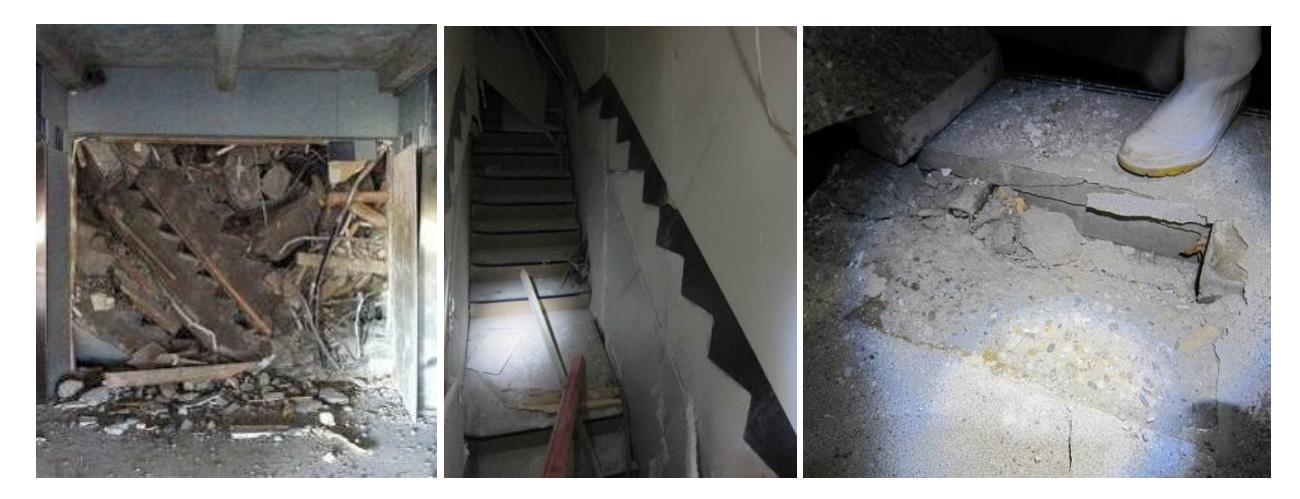
Figure 49: Collapse (a-b) and top landing damage (c) of precast concrete staircase in multi-storey buildings

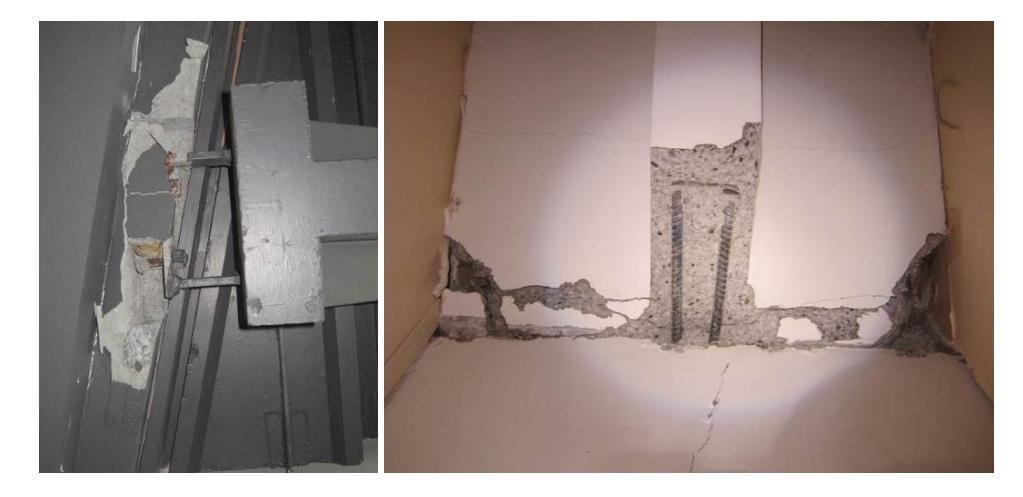
Figure 50: Bottom landing damage of precast concrete staircase in multi-storey buildings

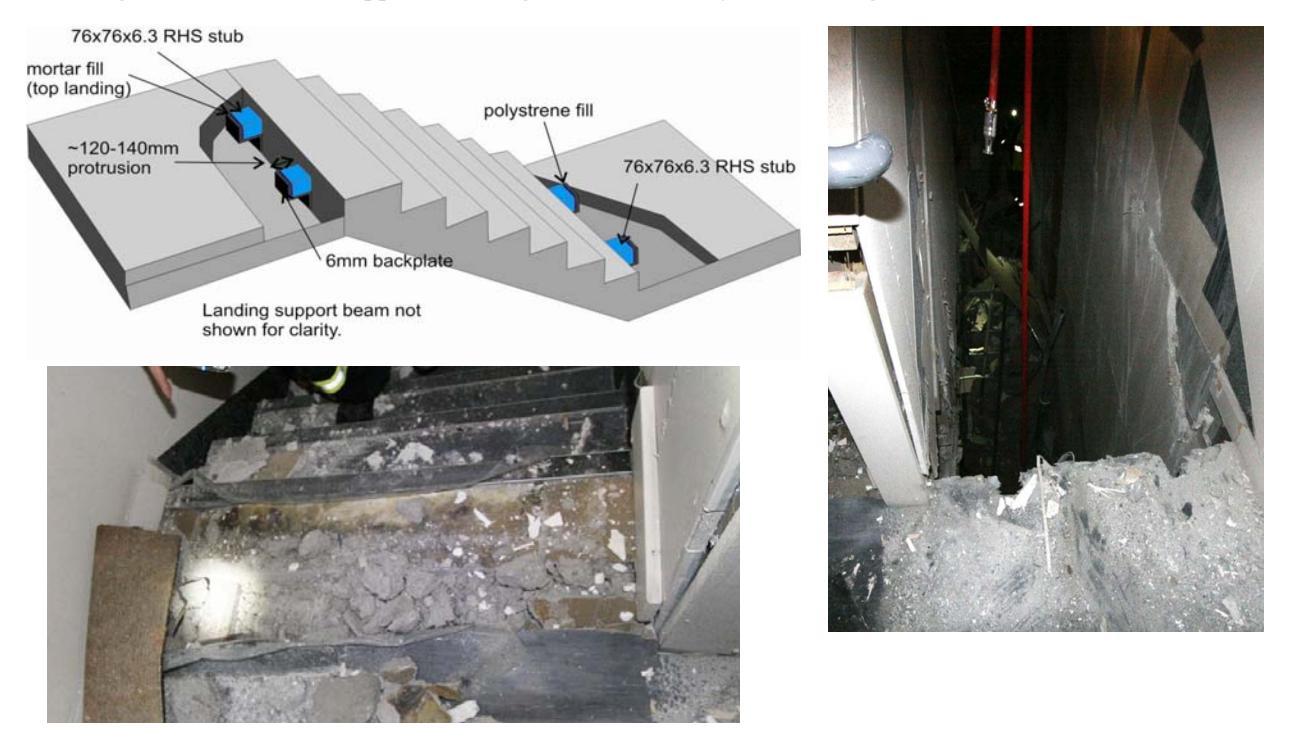
Figure 52: Alternative typical detailing of staircase- Type A - Pinned-slide connections with RHS shear keys on both ends and observed failures. (Damage photographs are courtesy of USAR teams)

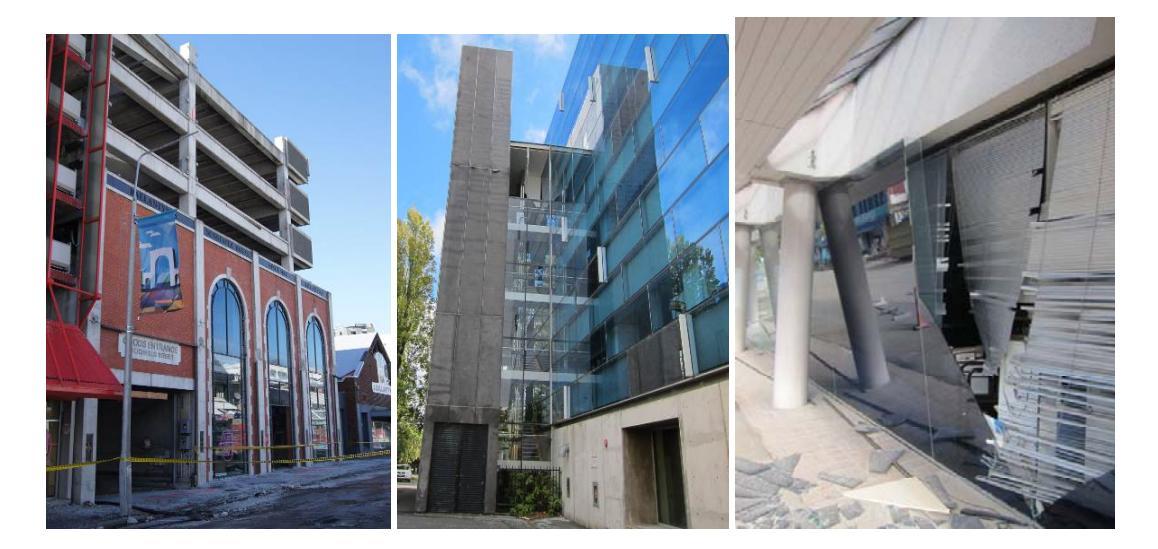
Figure 53: Damage and collapse of vertical "non-structural elements": a) Collapse of heavy precast concrete panels due to failure of the connecting bolted-plates; b) The failure of the inter-panel shear connection of an external lift-shaft located next to the only safety egress for the building; c) Shattered glass façade at street retail level

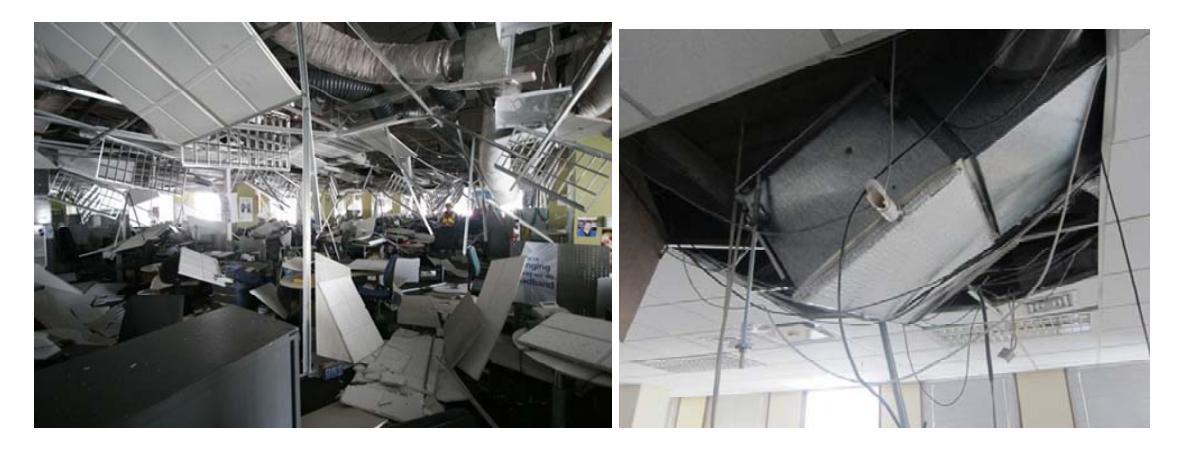
Figure 54: Damage and collapse of horizontal "non-structural elements": a) Collapse of heavy ceiling tiles and services b) Near collapse of a HVAC unit due to anchorage failure

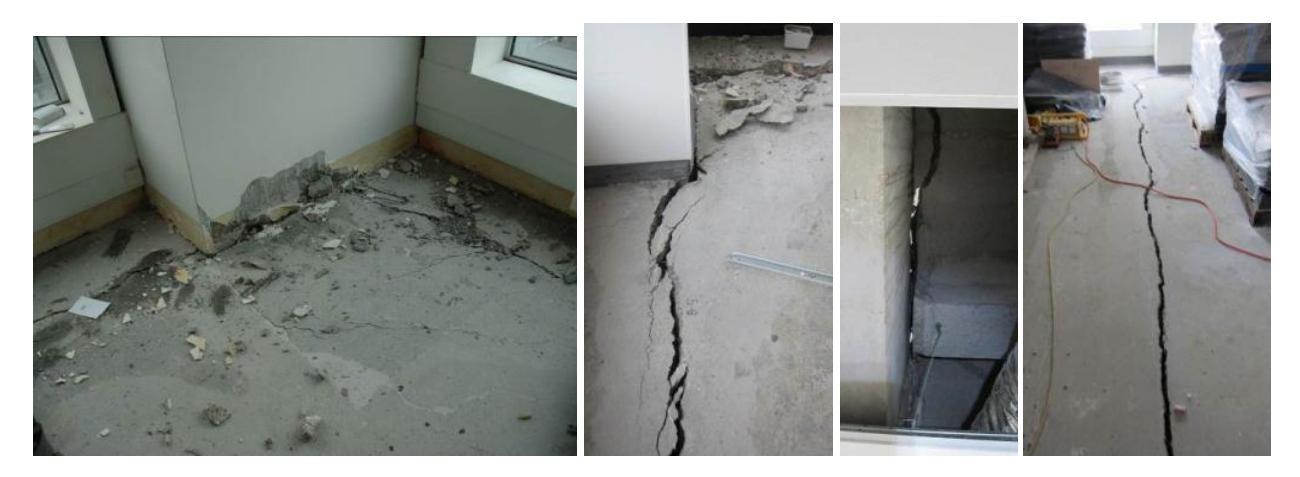
Figure 55: Extensive damage of floor diaphragm and loss of floor support due to the beam-elongation effects of concrete frame inelastic response

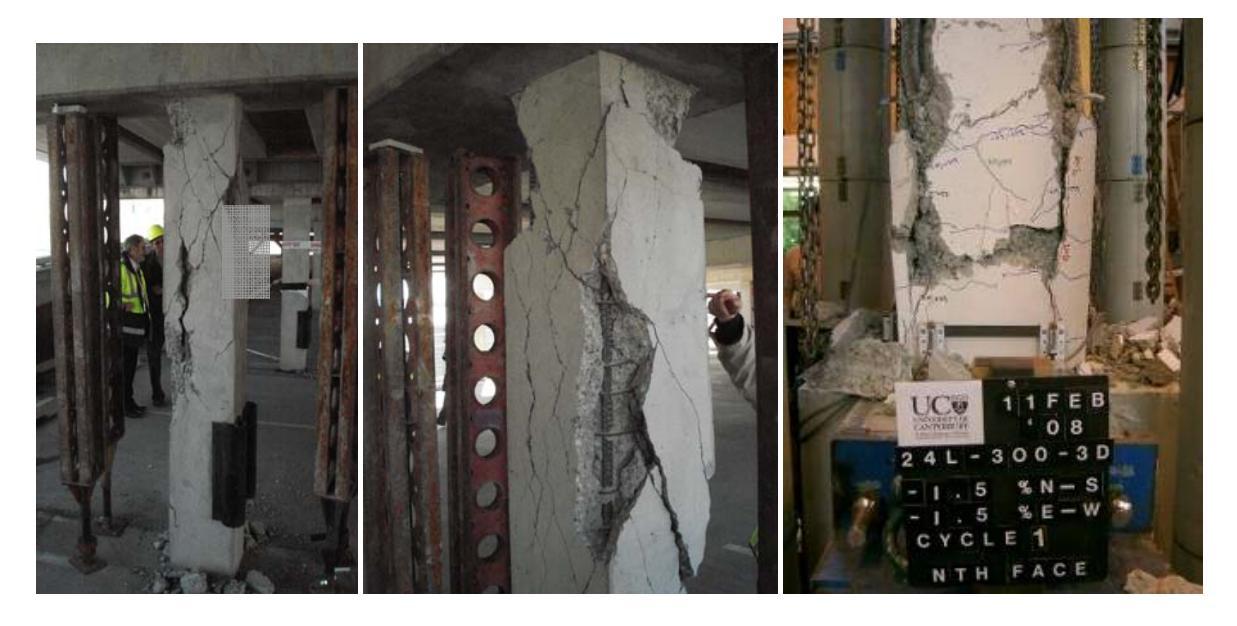
Figure 56: Severe damage with loss of vertical load-bearing capacity in columns with inadequate trasverse reinforcement as part of the "gravity-load systems" due to displacement compatibility with the lateral load resisting systems (Left: damage observed after the 4 Sept earthquake; Right: experimental tests carried out years before on typical pre-1995 gravity-load columns subjected to bidirectional cyclic loading
