# Estimating the Risk to Life Safety during Earthquakes from Non-Structural Elements in Commercial Buildings in New Zealand

Prepared for Ministry of Business, Innovation and Employment (MBIE)

Prepared by Beca Ltd (Beca)

28 October 2016

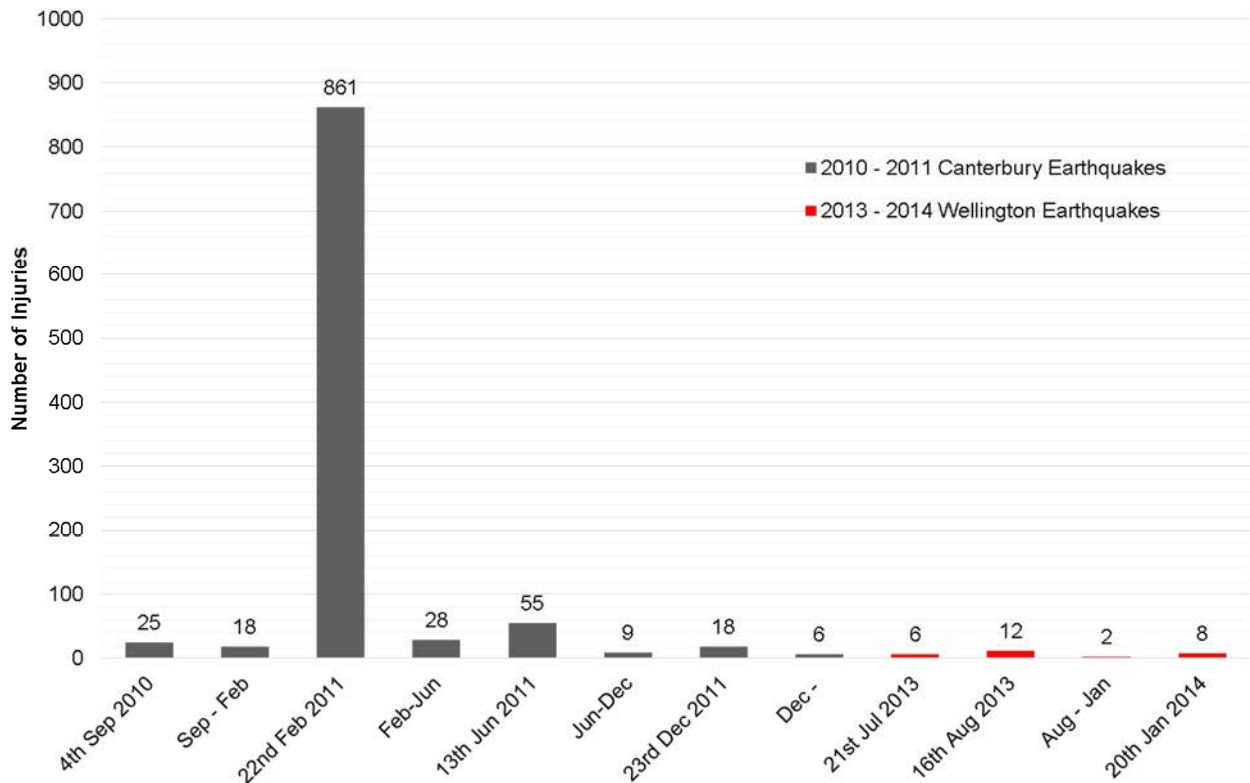
A total of 1,048 injuries were directly attributable to earthquake building damage, according to the earthquake events as shown in Figure 3 below. The injuries have been either attributed to the seven major earthquake events defined in the previous section, or to the time period between these major events. The time periods between major events include numerous aftershocks since no single aftershock event caused a significant number of injuries.

Figure 3: Total number of injuries for each earthquake event

The earthquake on 22nd February 2011 generated by far the most number of injuries. Overall injury statistics subsequently presented in this report are consequently distorted by this single earthquake event. The number of injuries in the 4<sup>th</sup> September 2010 earthquake was comparatively low for the magnitude of this earthquake. This is likely due to the earthquake occurring at 4:35am, when it would be expected that the majority of commercial buildings are unoccupied.

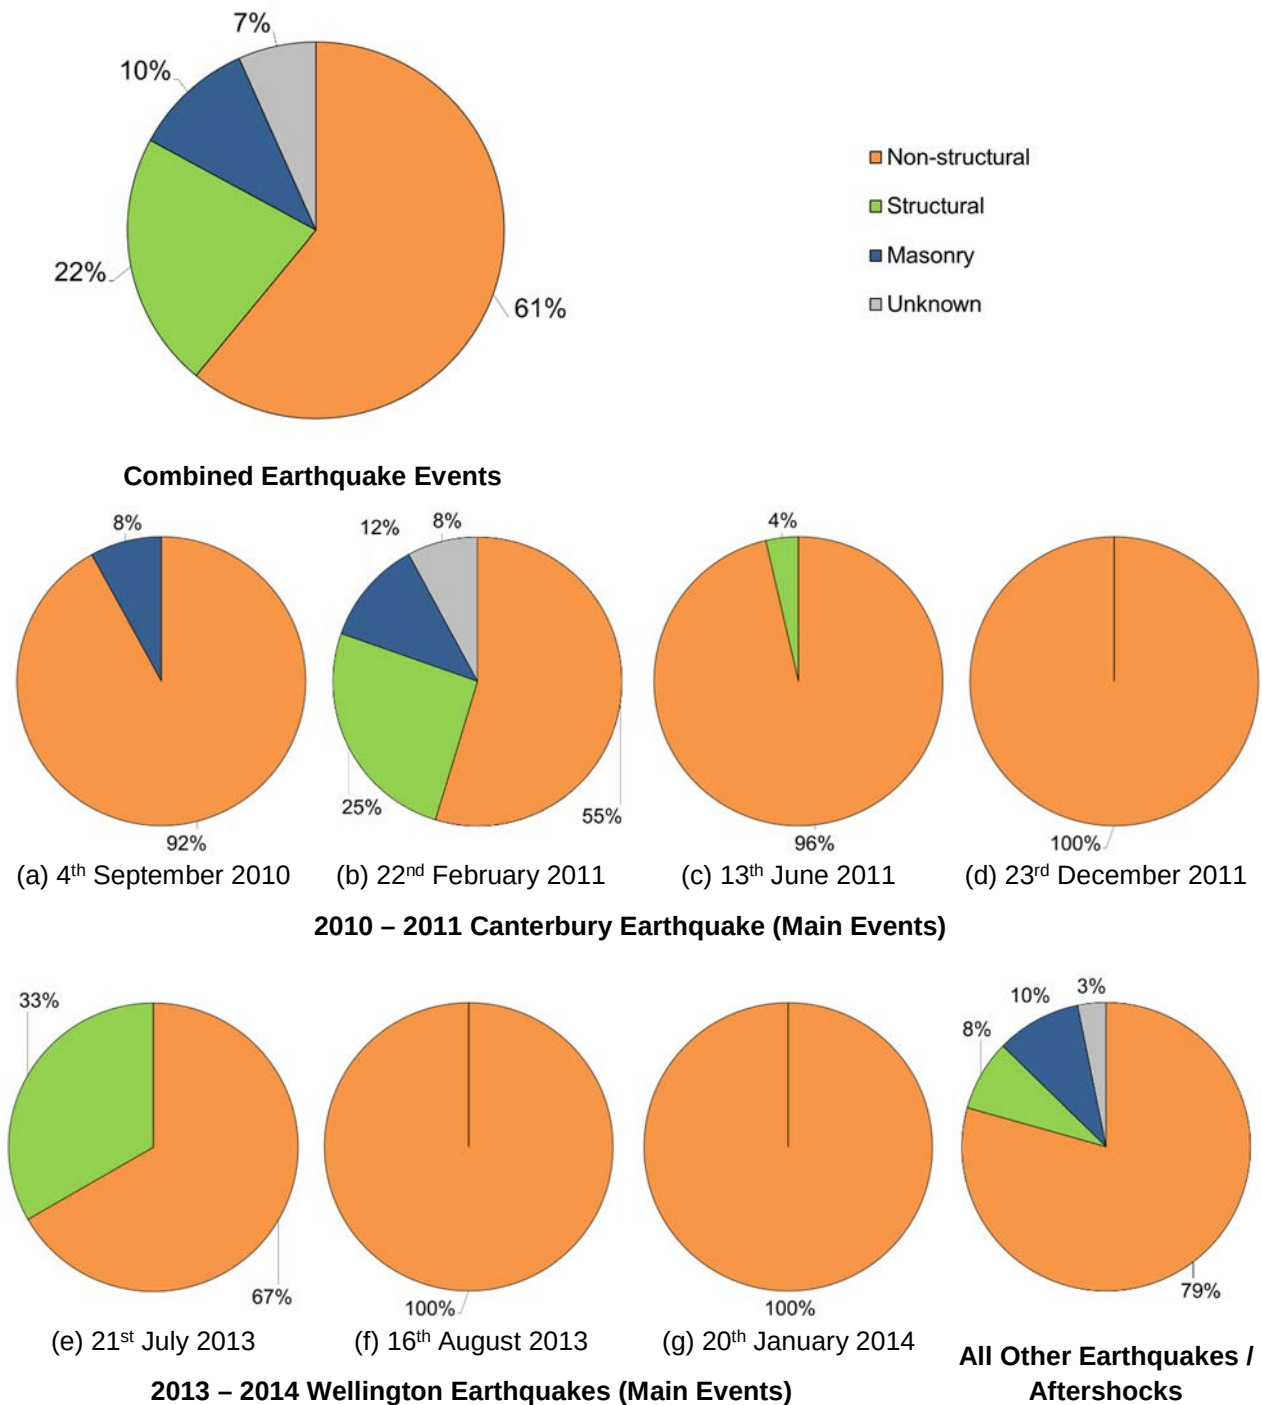
A breakdown of the cause of injury between the following categories: non-structural, structural, masonry and unknown, for the total 1048 identified injuries in the RHISE database for the earthquake events from 4 September 2010 is shown in Figure 4. Non-structural damage is the main contributor to earthquake injury, being the cause of 61% of all injuries.

Figure 4: Cause of injuries by building component

The contribution of structural and masonry damage to injuries was most noticeable in the 22<sup>nd</sup> February 2011 earthquake, with a significant number of injuries being attributed to the two reinforced concrete building collapses and the numerous unreinforced masonry failures (CERC, 2012a). This may have also been attributed to the instatement of the Central City Red Zone cordon which was a public exclusion zone established in the Christchurch CBD following the 22 February 2011 earthquake.

An injury categorised as 'Unknown' was deemed to be the direct result of damage to a building (as opposed to an indirect injury), however, categorising the component of the building that caused the injury was not possible due to lack of information. Cases where the injury cause was unidentifiable were excluded. The total number of injuries can therefore be considered to be a lower bound estimate, since it is likely more injuries were attributable to direct building damage, but the description was insufficient to conclude this with certainty.

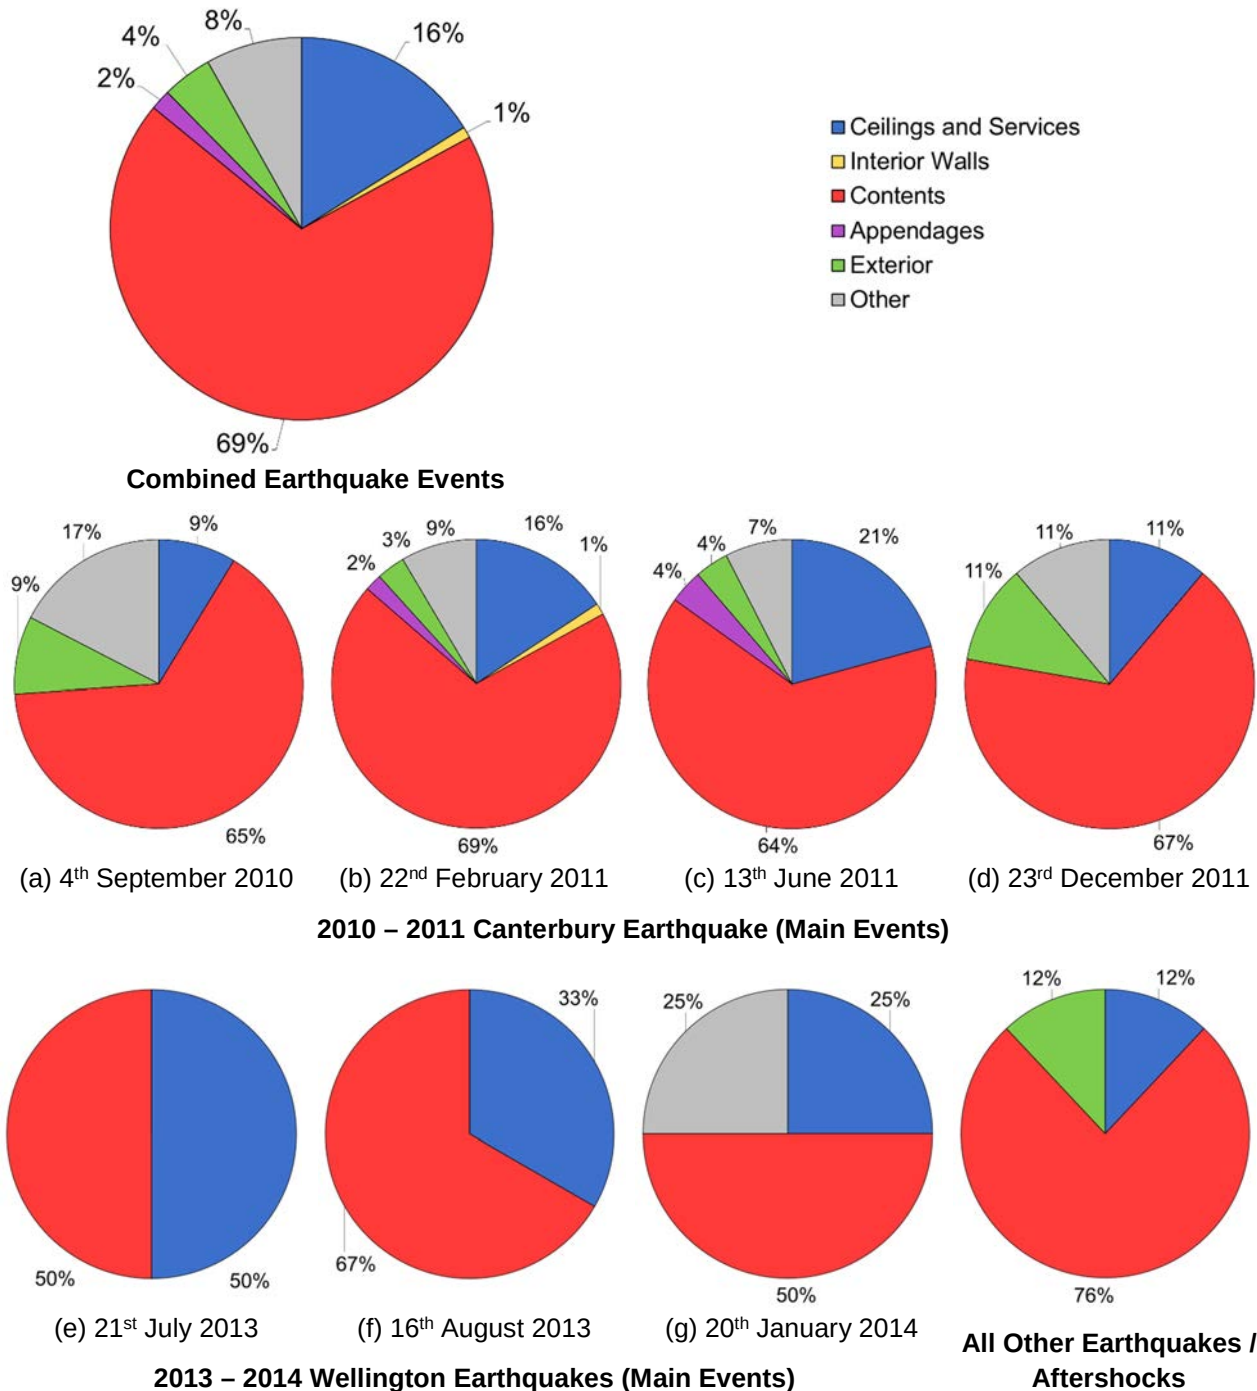
A breakdown of the cause of injury by non-structural elements for the earthquake events from 4 September 2010 is shown in Figure 5.

Figure 5: Cause of non-structural element related injuries

Contents related injuries were the dominant cause of injuries, making up 69% of all non-structural injuries (or 42% of all building related injuries overall). The proportions of injuries between the different non-structural categories was relatively consistent for all earthquake events, with contents always being the dominant

contributor. Ceilings and services were the second largest injury contributor. Appendages, exterior elements and other non-structural elements made a minor contribution to total injuries. Interior walls caused very few injuries, as damage to these elements rarely resulted in fall-out of the interior wall, hence not posing a significant injury hazard.

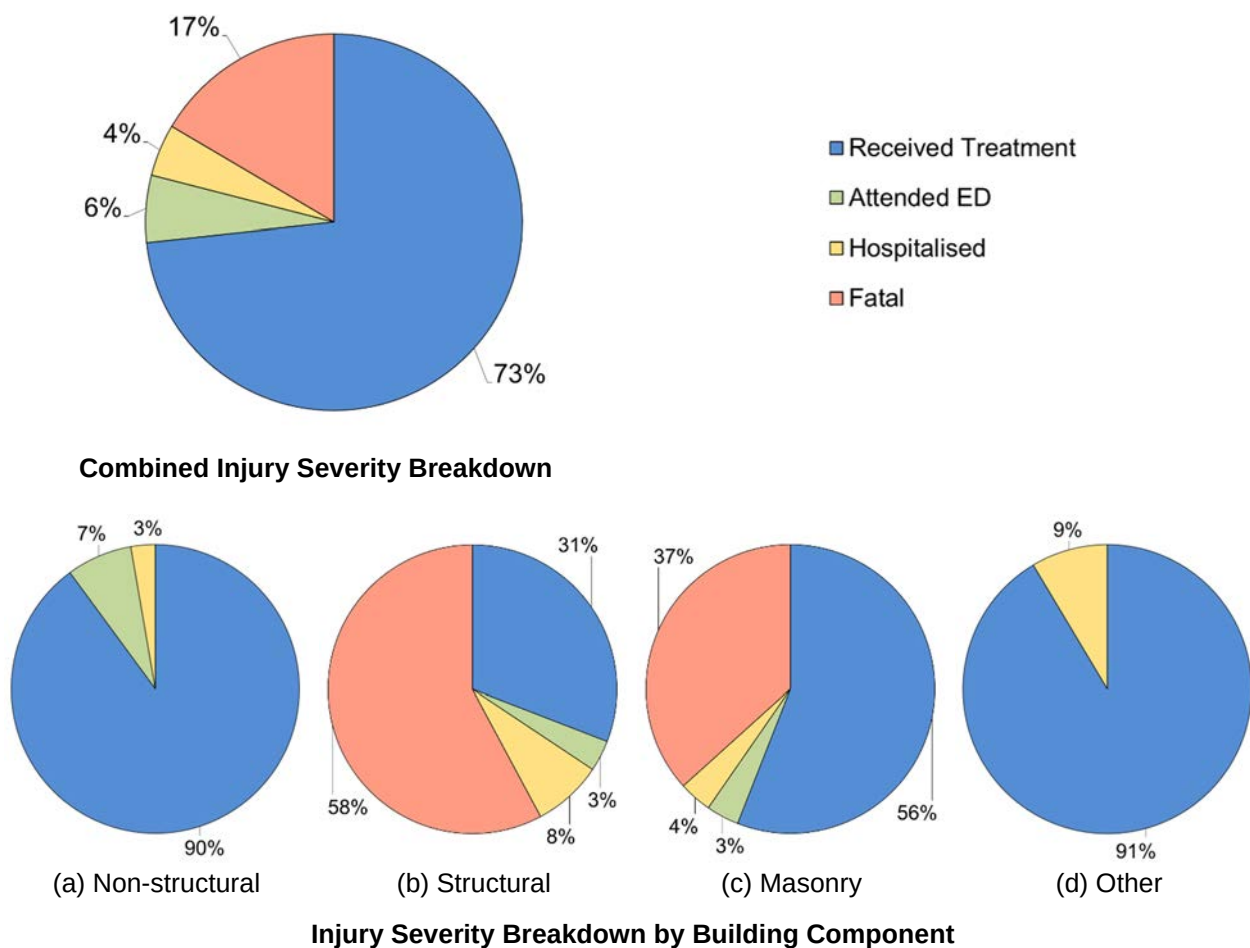
The severity of injuries due to damage from all building components (structural and non-structural) for all earthquake events considered is shown below in Figure 6. As would be expected, the majority of injuries were more minor in nature, with injuries receiving treatment outside of hospital contributing to 73% of injuries within the research scope. Since self-reported injuries (i.e. people who were injured but did not seek any form of treatment) are not represented in the data, it is likely that minor injuries are under reported. Fatal injuries comprise the second highest number of injuries, totalling 173. This can be attributed to the deaths that resulted from the two building collapses and the numerous unreinforced masonry failures the 22<sup>nd</sup> February 2011 earthquake.

Figure 6: Breakdown of injury severity by building component

The previous section demonstrated that non-structural elements caused the greatest number of injuries, however Figure 6 reveals that 90% of these non-structural injuries were at the lowest injury severity level. There were also no fatalities from damage to non-structural elements in commercial buildings, though there were recorded fatalities which occurred in residential buildings and from the failure of secondary structural elements (CERC, 2012b). The majority of injuries requiring ED treatment, or hospitalisation were also due to non-structural damage, which highlights the large proportion of overall injuries due to non-structural damage causes, as shown earlier in Figure 4.

It is shown in Figure 6b that the majority (58%) of structural building component related injuries were fatal. All of the fatalities resulting from structural damage were a result of the two building collapses that occurred on the 22<sup>nd</sup> February 2011. Of the non-fatal injuries caused by structural damage, many of these injuries could also be attributed to the collapse of these two buildings. This emphasises the critical role that structural collapse prevention plays in life-safety protection. A large proportion of masonry related injuries also resulted in fatalities, demonstrating that this also poses a significant life-safety hazard.

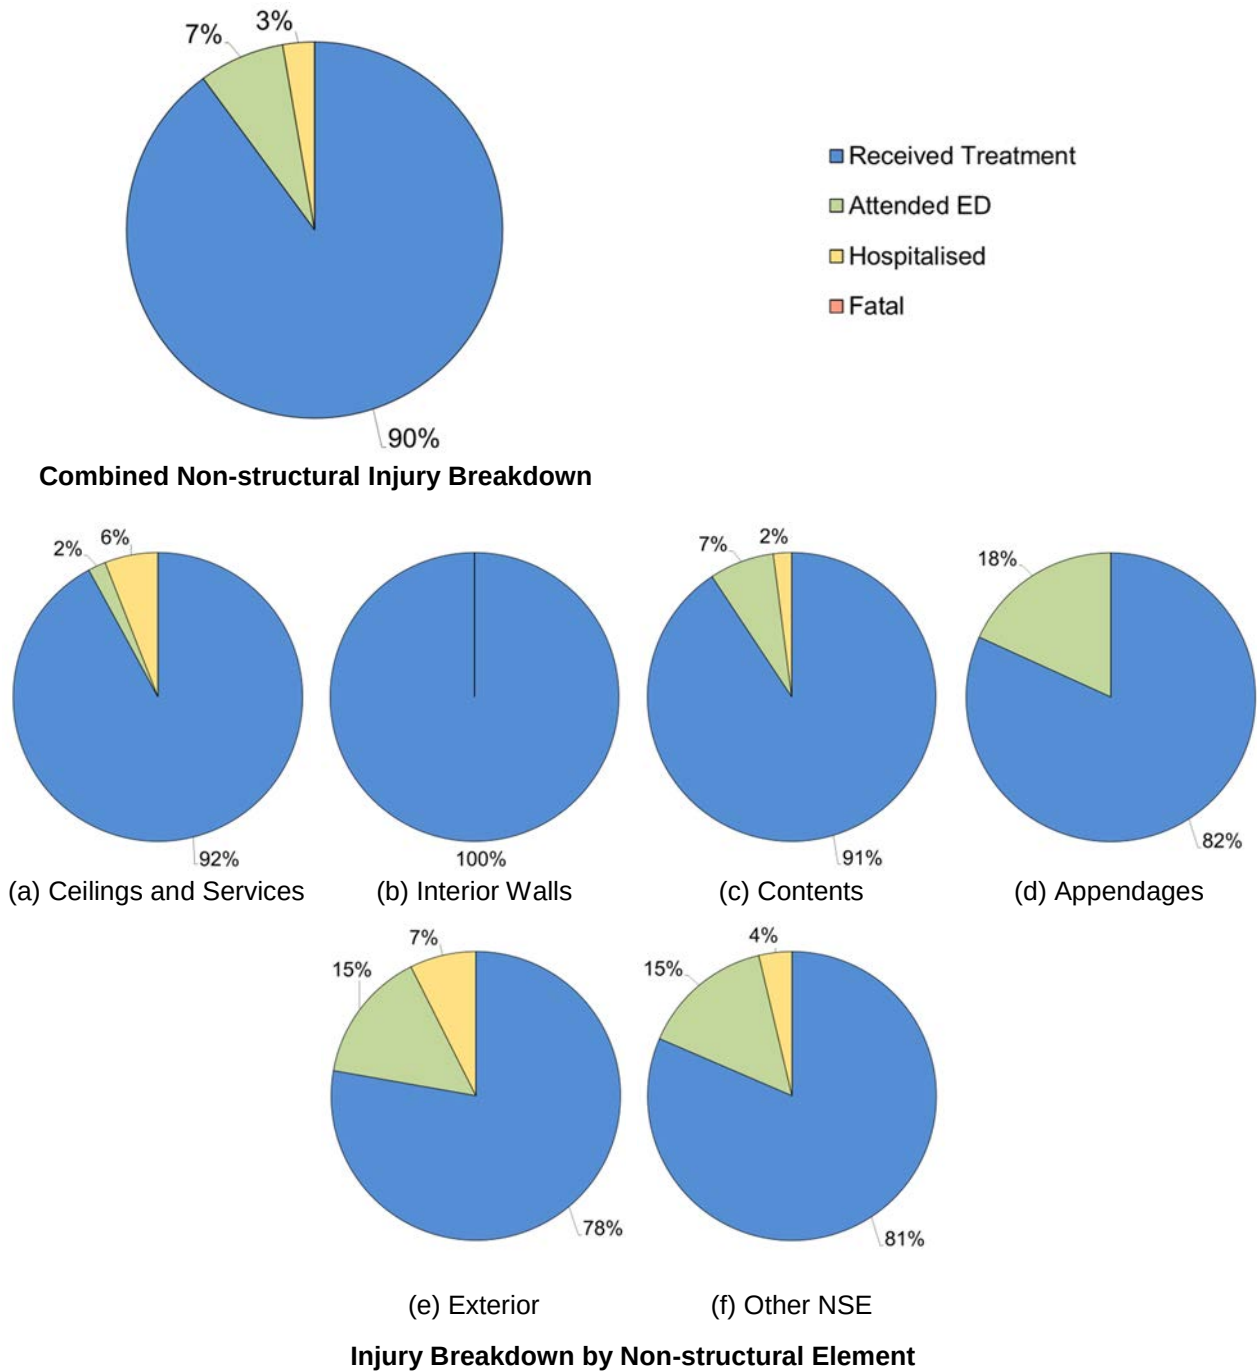
The proportion of injury severity can be further broken down by non-structural element type, as presented in Figure 7. The proportions are generally similar for each type, and since contents are the dominant injury cause, the breakdown of content injuries is nearly identical to that of the combined non-structural injury breakdown.

Figure 7: Injury Breakdown by Non-structural Element Type

It can be seen in Figure 7 that exterior elements caused the greatest proportion of injuries that required emergency department treatment, or admission to hospital. Such injuries are likely attributable to glass falling from height, which was widely reported following the Canterbury earthquakes (Baird et al., 2011).

Appendages also caused several injuries requiring emergency department treatment, which is likely related to being heavy non-structural elements falling from height similarly to exterior elements. Injuries attributed to interior walls were rare, and also only ever minor in severity. Such elements evidently do not present a significant issue from a life-safety viewpoint based on the research data.

Ceilings/services injuries and contents injuries had a similar proportion of injuries that required emergency department treatment or hospitalisation. However, contents had a greater number of injuries overall, so the number of contents related injuries requiring treatment is greater. Based on the data we can conclude that if an occupant of a commercial building in New Zealand is injured in an earthquake, the most likely cause of the injury is building contents, however, the severity of the injury is most likely to be minor.

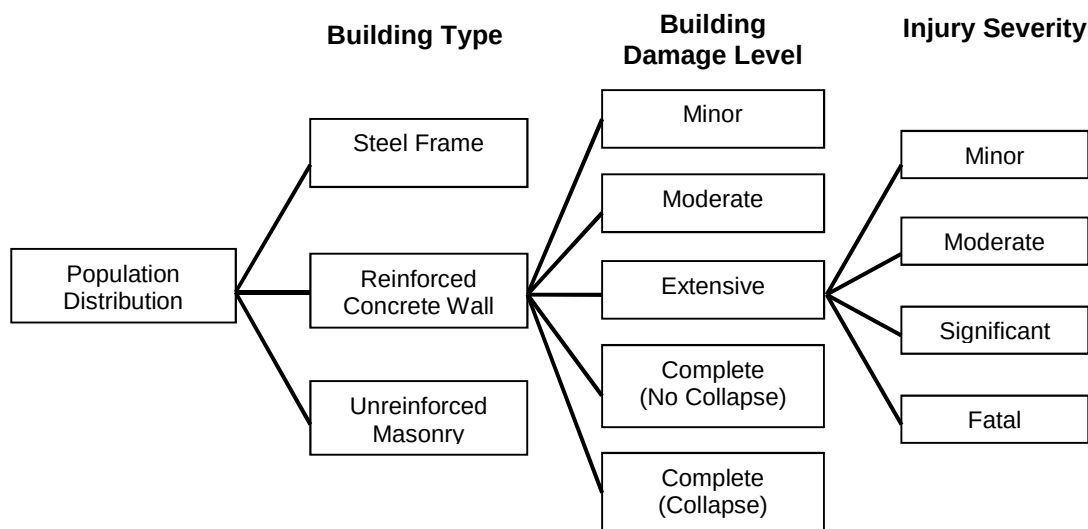
The most commonly used event-tree approach is shown in Figure 8; where (i) the population present within each building type are estimated, (ii) the global damage level for each building type is predicted, and (iii) injury rates are assigned for each damage level. Examples of models which follows this approach include the Cambridge University Casualty Model (Coburn et al., 1992), HAZUS® (FEMA, 2015), and Mitrani-Reiser (Mitrani-Reiser, 2007). While this approach may be adapted to consider non-structural element failure rather than the building's damage level, no studies exists linking non-structural element failure to injury severity.

Figure 8. Event tree model for indoor casualty prediction HAZUS® (FEMA, 2015)

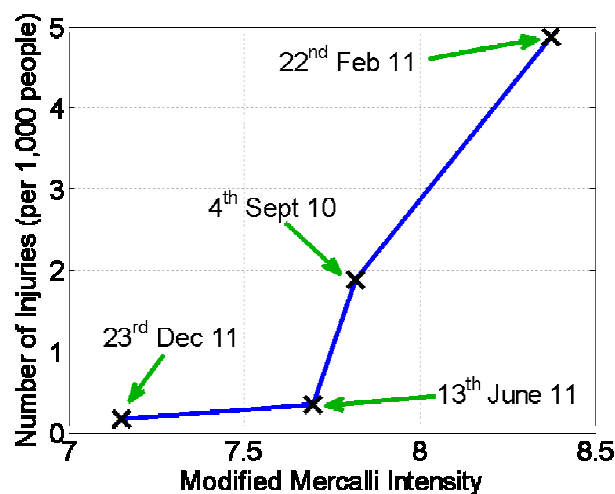
The non-structural injury model represents the relationship between the ground shaking intensity with the injury rate. It consists of a data point that relates these two variables for each earthquake event considered, as shown in Figure 9. The injury model presented in Figure 9 considers injuries from all non-structural elements. The relationship shows that the injury rate increases with ground shaking intensity which is reasonable. The injury rate varied between 0.1 and 4.9 injuries attributable to non-structural damage per 1,000 people, depending on the intensity of ground shaking.

Figure 9: Non-structural element injury rate versus ground shaking

The two lowest injury rates were the last two significant events of the four Canterbury earthquake sequence events considered. It is likely that these injury rates may have been higher had they had not followed larger

This injury model can be used as a tool for estimating the number of injuries in other earthquakes. However, the model is implicitly Christchurch specific, meaning that the factors linking MMI to injury severity, such as soil type, building typology, non-structural element types, building populations, etc., are representative of Christchurch in the years 2010-2011. Any further application therefore assumes that these 'filters' are an appropriate representation of the place that they wish to estimate injuries for. That's not to say that such a model is unusable, as it will likely provide a better estimate of possible injury numbers compared to equivalent models developed outside of New Zealand, which have been passed through their own local filter. Further data will help in improving the validity of the model and widen its application.

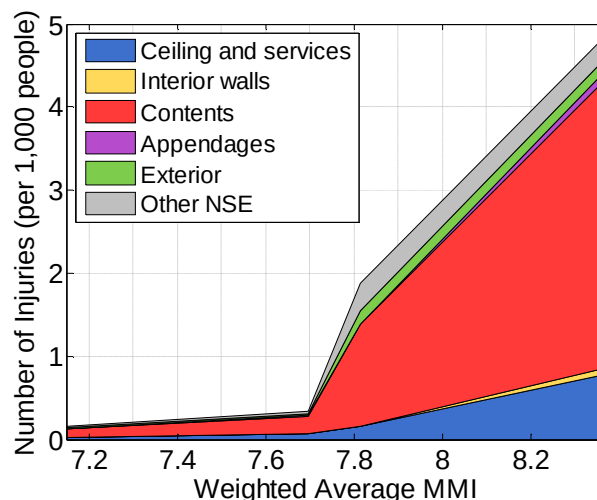
The injury rate can also be broken down to show the individual contribution of each non-structural element type considered, as shown in Figure 10. As would be expected, contents injuries are the main contributor to the overall non-structural injury rate. The contribution of each non-structural component to the overall injury rate appears to be relatively consistent for different levels of ground shaking. It appears that interior wall and appendage injuries only register under large shaking.

Figure 10: Breakdown of non-structural element injury rate versus ground shaking

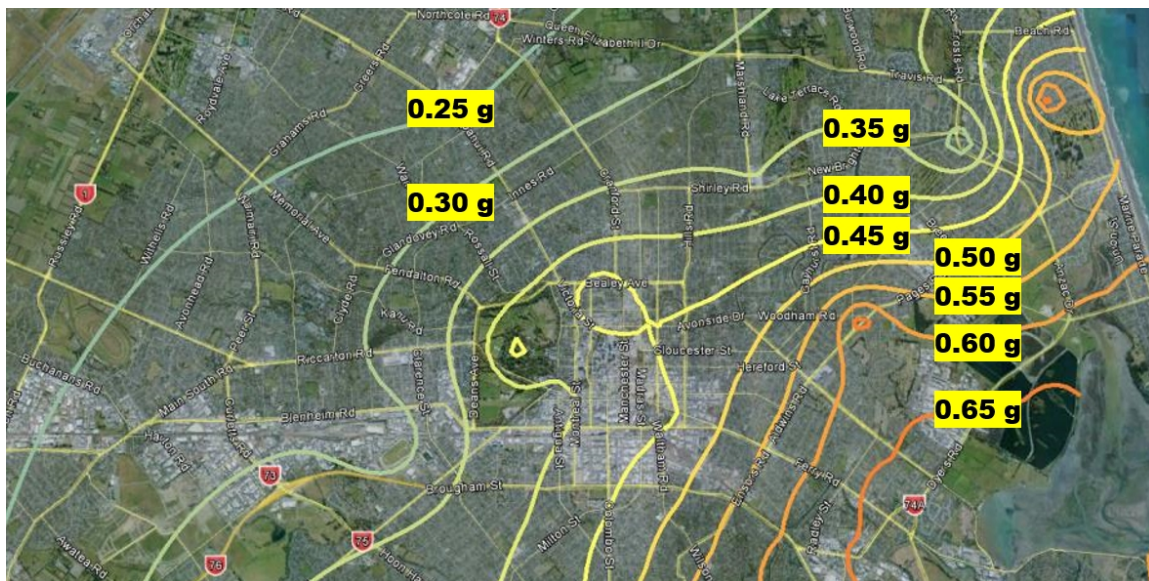
PGA and PGV spatial distribution data across Christchurch City by Bradley (2014) was used to estimate the shaking intensity for each of the four major events. A contour map showing the PGA across Canterbury based on these studies is shown in Figure 11. Since the majority of commercial buildings are located within the four main avenues of Christchurch (Deans, Bealey, Fitzgerald, and Moorhouse), the average PGA and PGV within this region is taken as the representative shaking intensity of the respective events. Two values of MMI was then calculated for each event; one using PGA and the other using PGV. The larger MMI of the two was used as the representative shaking intensity value of each respective shaking event.

Figure 11: Median PGA contour map from 22<sup>nd</sup> February 2011 Canterbury earthquake event
