EXPERT PANEL REPORT

Structural Performance of Christchurch CBD Buildings in the 22 February 2011 Aftershock

February 2012

Report of an Expert Panel appointed by the New Zealand Department of Building and Housing

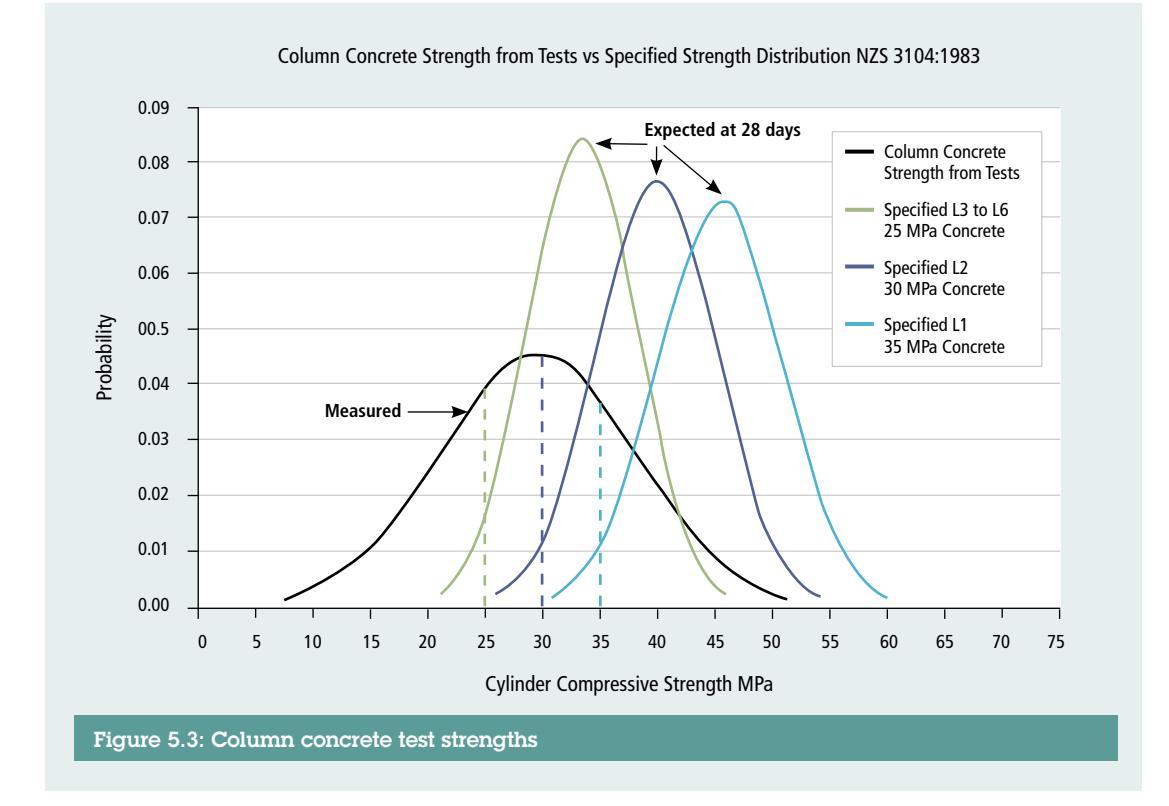
- All reinforcing steel appeared to conform to the standards of the day.
- Concrete strengths in concrete from south wall and north core wall samples were found to be greater than specified.
- Tests on 26 column samples (21% of all CTV Building columns) indicated that, at the time of testing, the column remnants from Levels 1 to 6 had a mean concrete strength of 29.6 MPa, with measurements ranging from 17.3 MPa to 50.3 MPa.

The position in relation to the column samples is summarised in Figure 5.3. The black line indicates the inferred distribution of concrete strengths from the tests. The other three distributions are the expected strength distributions at 28 days from pouring of concrete based on the specified concrete strengths (after 28 days) which were 35 MPa for Level 1 columns, 30 MPa for Level 2, and 25 MPa for Levels 3 to 6. Even though it is not known which of the measurements applies to which expected strength distribution, it can be seen that a higher than expected proportion of the results is below the specified level in all cases.

While it is recognised that the tests were conducted on members that had been involved in the collapse, the results indicate that column concrete strengths were significantly less than the expected strength considering the specified strengths, the conservative approach to achieving specified strengths, and the expected strength gain with age.

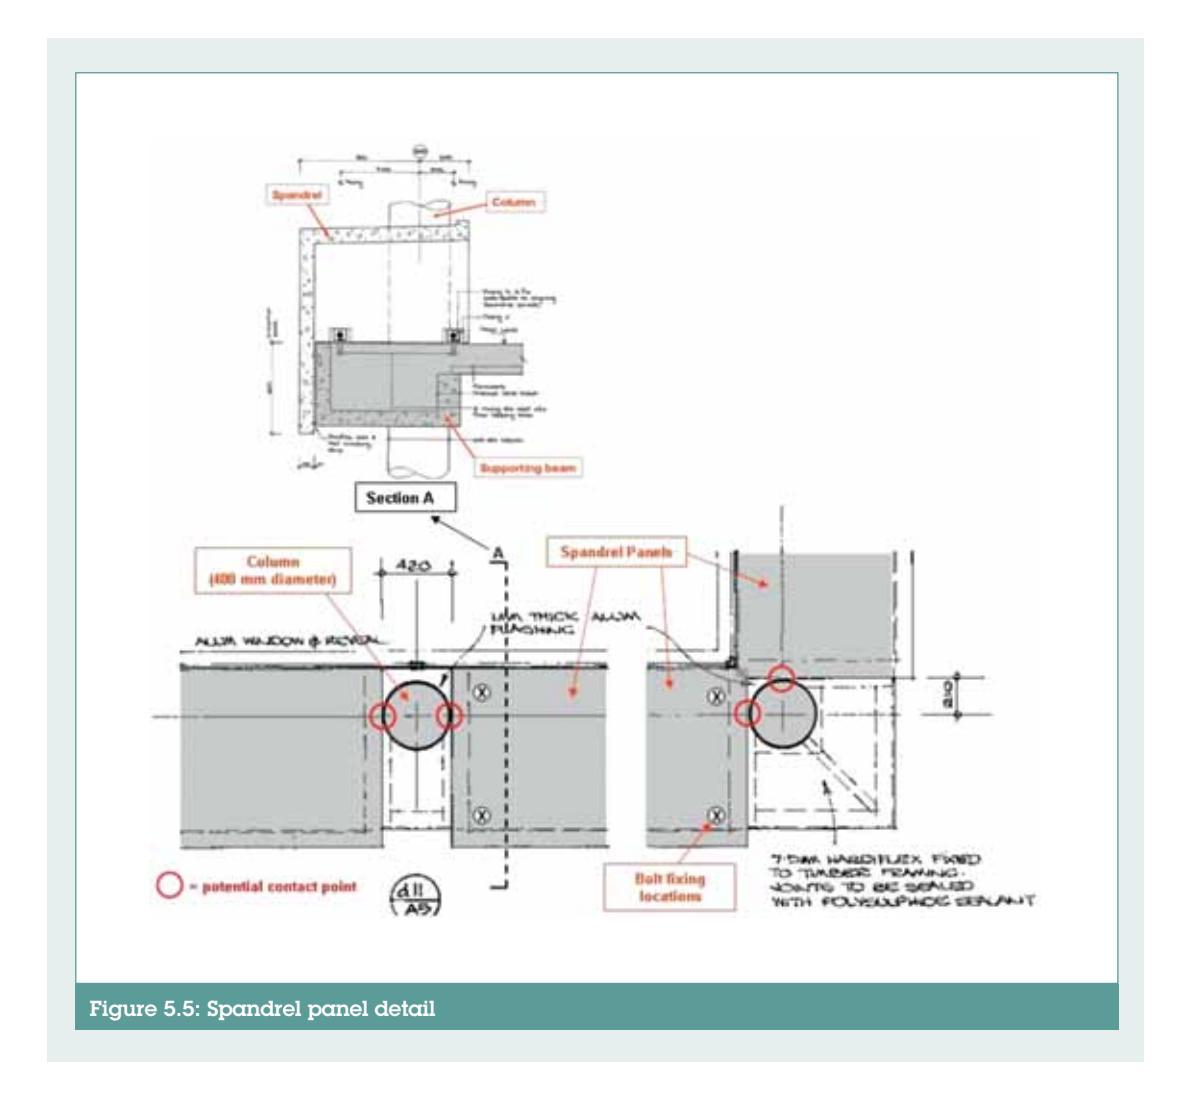
A plan and a cross-section of the typical column and spandrel panel arrangement are shown in Figure 5.5.

The pre-cast reinforced concrete spandrel panels were fixed to the floor slab and were placed between columns. The gap between the ends of adjacent spandrels was specified to be 420mm giving a nominal 10mm gap either side between the spandrel and the column. It is possible that these gaps varied from the nominal 10mm and it is estimated they may have ranged between 0 and 16mm. It is not known what the sizes of the gaps actually were, but analyses showed a significant reduction in column drift capacity for the case where no gap was achieved. Forensic evidence indicated that interaction may have occurred between some columns and adjacent spandrel panels in the 22 February 2011 event. There were also indications of cracking reported in some of the upper level columns after the September earthquake that may have indicated some interaction with the spandrel panels.

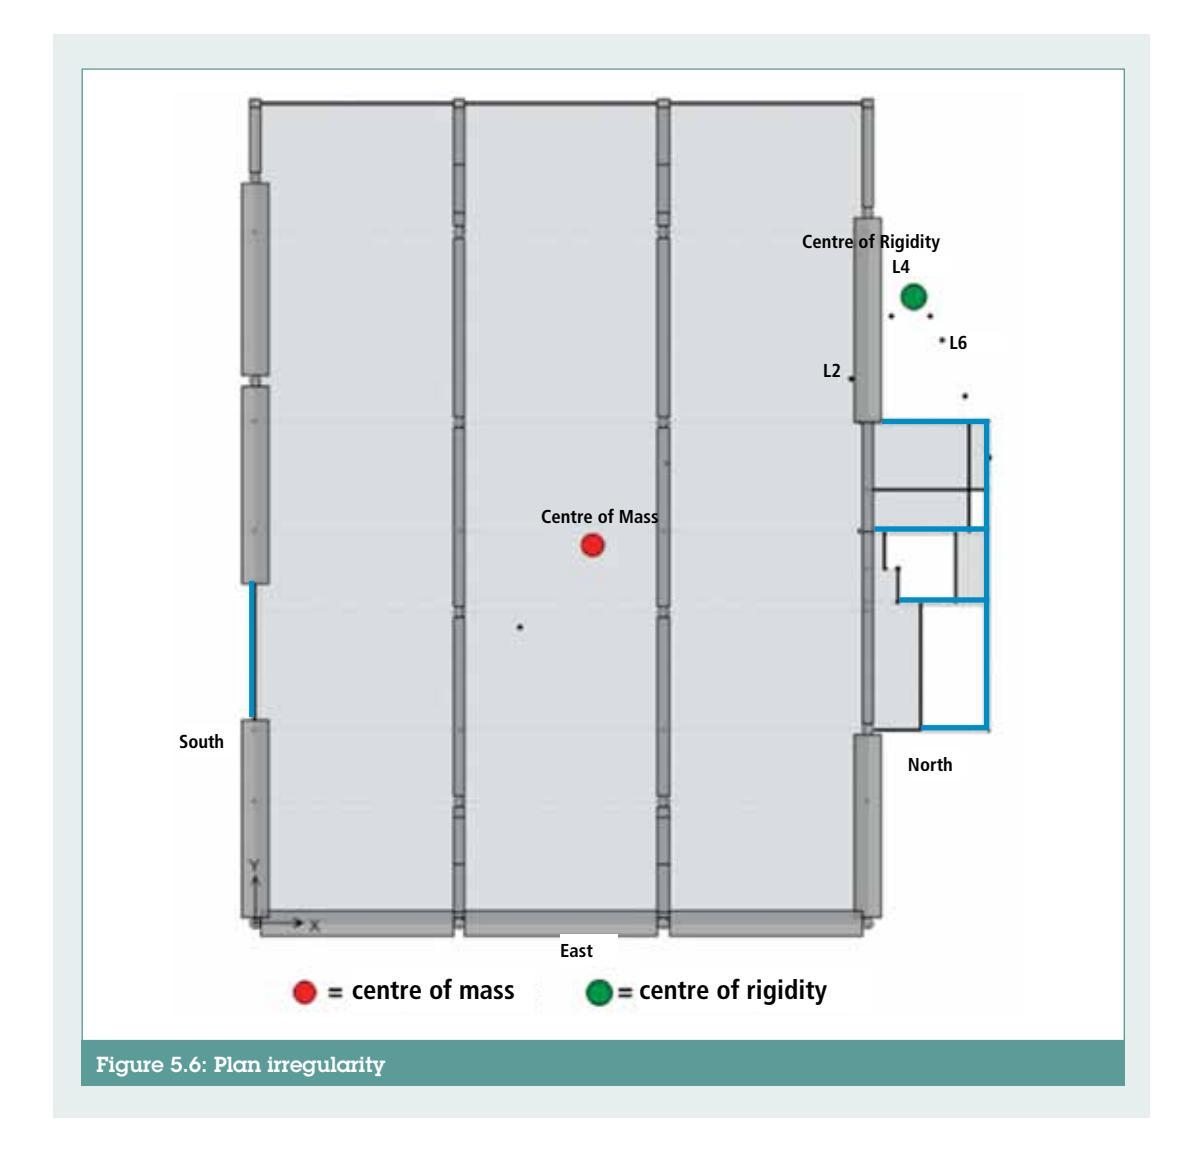
- lack of symmetry in plan of the concrete shear walls (north core and south wall)
- vertical and plan irregularity due to lack of separation between the frame and masonry infill walls on the west face.

It was considered that the lack of symmetry in plan could cause displacements on the south and east faces to increase as the building rotated in plan. Figure 5.6 illustrates the results of one examination of this effect. The centre of mass indicates where the lateral forces would act. The centre of rigidity indicates where lateral forces, at Level 4, would be resisted. The horizontal distance between these points is a measure of the tendency of the building to twist when subject to horizontal ground motions.

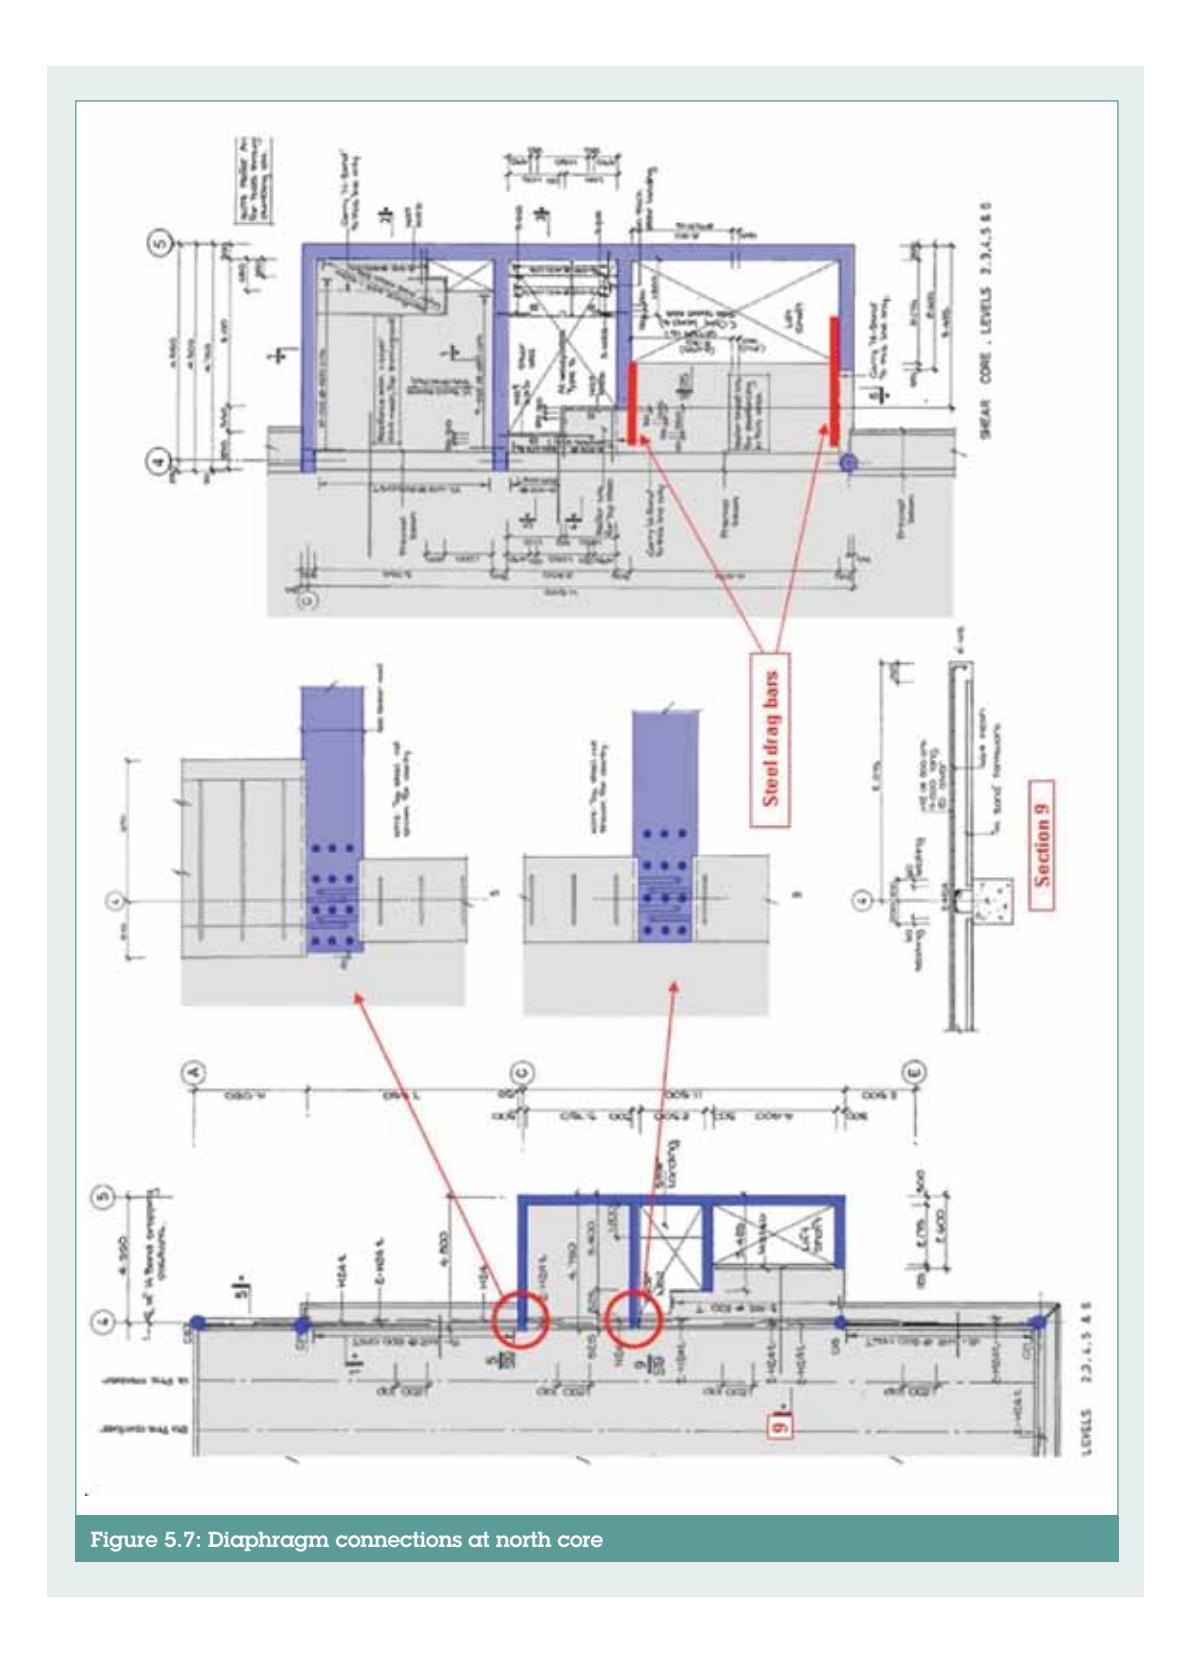
Following an independent consulting engineer's pre-purchase review in January 1990, drag bars were designed by the design engineer in October 1991 and subsequently installed at Levels 4, 5 and 6 to improve the connections between the floor slabs and the walls of the north core (refer to Figure 5.7). These connections were vital to the integrity of the building since the walls provide lateral stability and strength to the building.

Other structural modifications to the building included the formation of a stair opening in the Level 2 floor next to the south wall. Coring of the floors for pipes was found to have occurred at the locations where the slab pulled away from the lift core during the collapse. However, neither the stair opening nor the coring of floors appears to have been a significant factor in the collapse on 22 February 2011.

Figure 5.7 shows plans of the area where a typical floor slab (shaded grey) meets the stabilising walls of the north core (shaded blue). The large lateral forces from the floor slab must be transferred to the walls at the (limited) places where slab and wall elements meet and through the drag bars (shaded red) which were added at Levels 4, 5 and 6 in October 1991. These connections were seen as vulnerable and there was a possibility that the diaphragm (slab) would separate from the walls, resulting in increased lateral displacements and higher demands on critical columns.

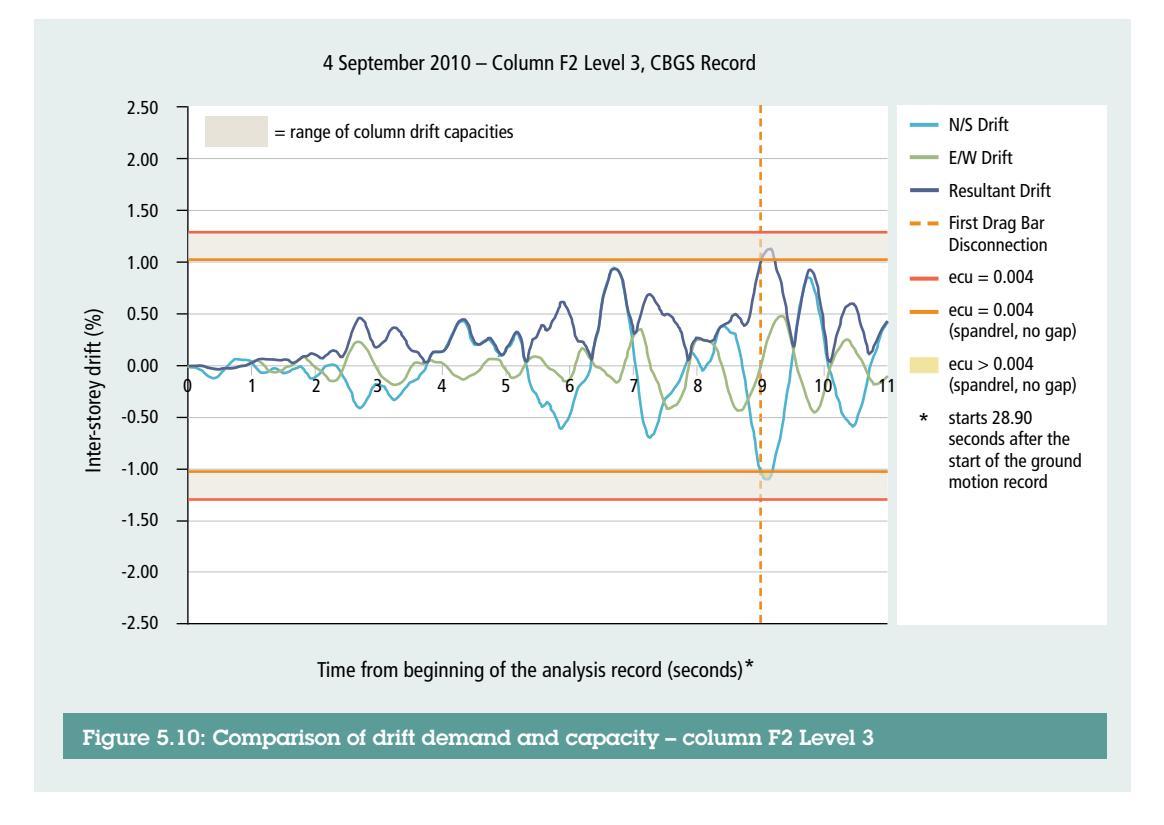
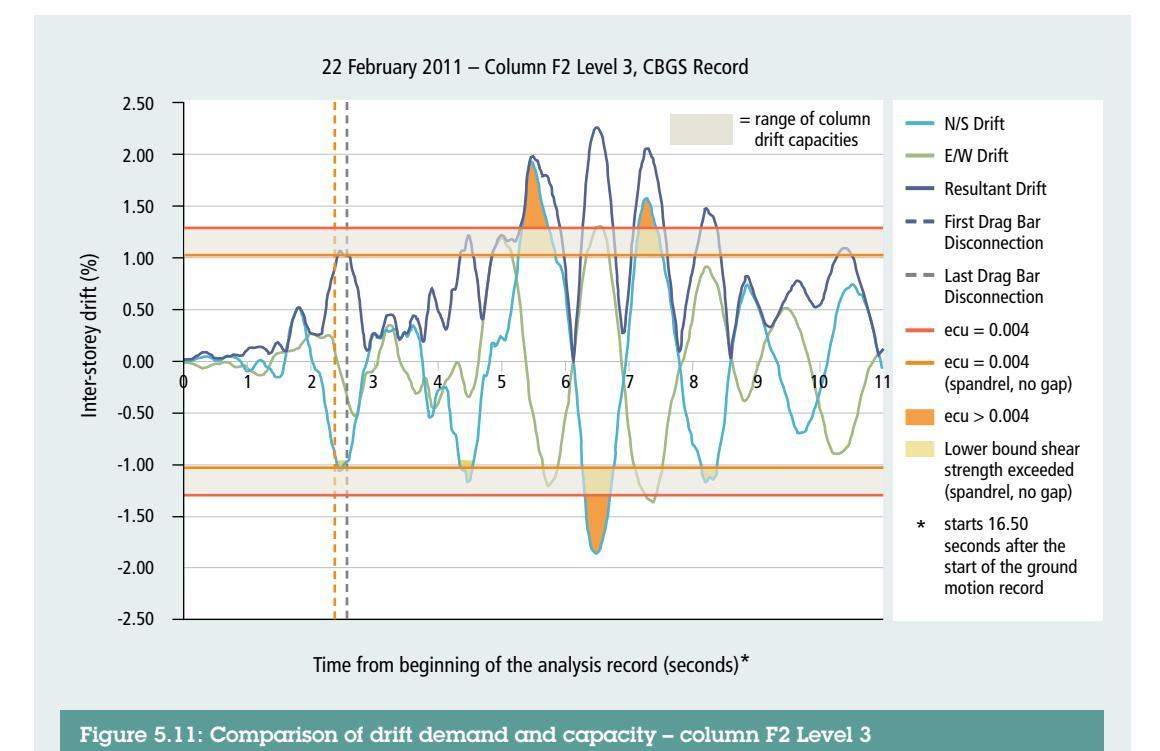
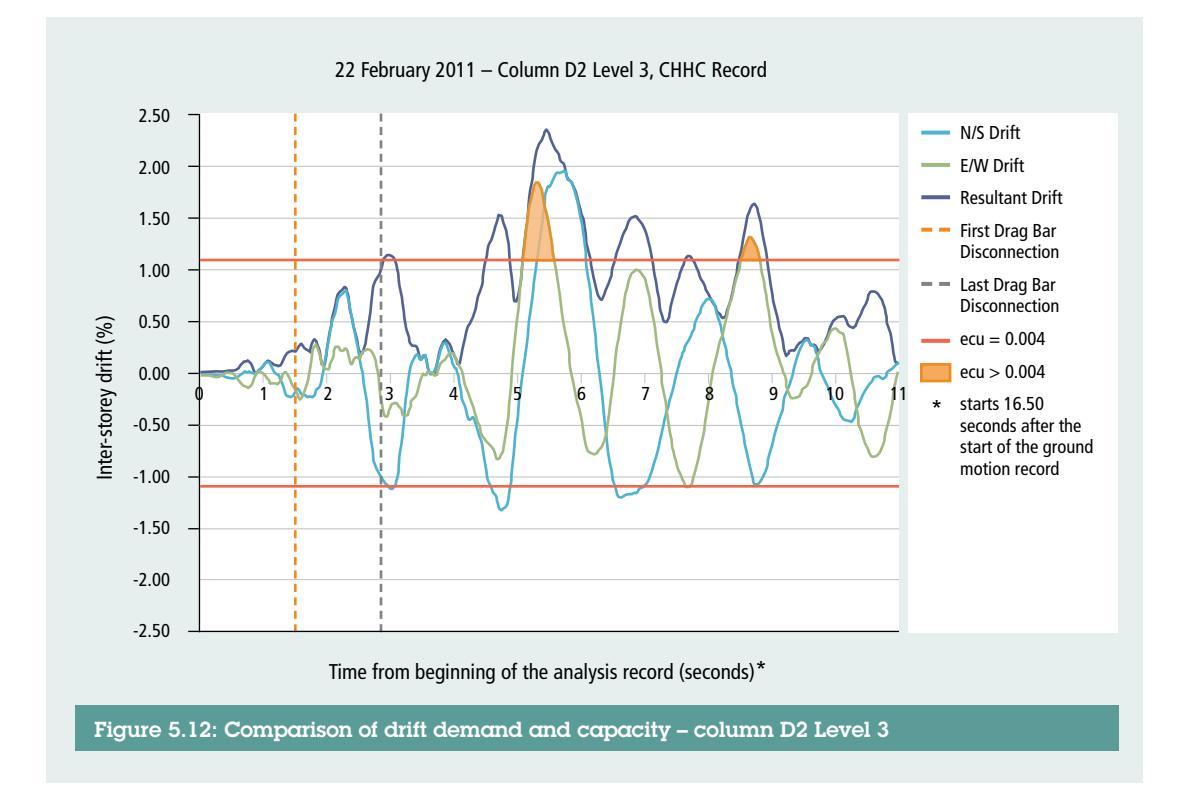
Figure 5.10 and Figure 5.11 show output from the non-linear time history analyses for column F2. Figure 5.12 shows output from the analyses for column D2. The vertical axis shows the amount of interstorey displacement (drift) at this column location. The horizontal axis is the time from start of shaking (as input into the analysis). The wavy lines plot the drift level over time and are based on application of the full ground shaking record in the analyses. This drift is a key measure of demand on the column. The light blue line shows the north-south drift which is critical for the grid F columns, taking into account the stiff façade beams and the potential interaction with spandrel panels. The dark blue line indicates the resultant drift of the north-south and east-west drifts.

Note that the time shown on the horizontal scale in Figure 5.10, Figure 5.11 and Figure 5.12 is the time from the start of the analysis. For the 4 September 2010 case, analysis started at 28.90 seconds from the start of the ground motion record. For the 22 February 2011 cases, analyses started at 16.50 seconds. Thus the maximum response shown on Figure 5.11 at around 5.5 seconds into the analysis corresponds to 22 seconds from start of the ground motion record.

The horizontal lines represent the estimated capacity of this column to sustain the drift without failing according to various criteria (assuming average concrete strength and without vertical earthquake effects). The band between the horizontal lines in Figures 5.10 and 5.11 reflects the difference between "no interaction with the spandrels" (higher value) and "full interaction with the spandrels". The areas where the drift has exceeded the estimated capacity are shown shaded dark orange. The band showing the range of capacities would be wider if allowance was made for the effect of variable concrete strength and vertical earthquake forces in the column.

Similar plots were made for column D2 at Level 3, shown in Figure 5.12, with similar conclusions being reached regarding the likely performance of this column in the 22 February 2011 event.

Displacements for column D2 on Level 1 (ground floor) (for the full record) were well below the assessed capacity of this column for 4 September 2010 and only marginally exceeded the capacity for the 22 February 2011 analysis. This is a broad indication that this column is less likely to have been the initiator of the collapse. However, this possibility cannot be ruled out because this column may have had lower than average concrete strength and/or suffered more from the effects of the considerable vertical forces generated in the 22 February 2011 event.

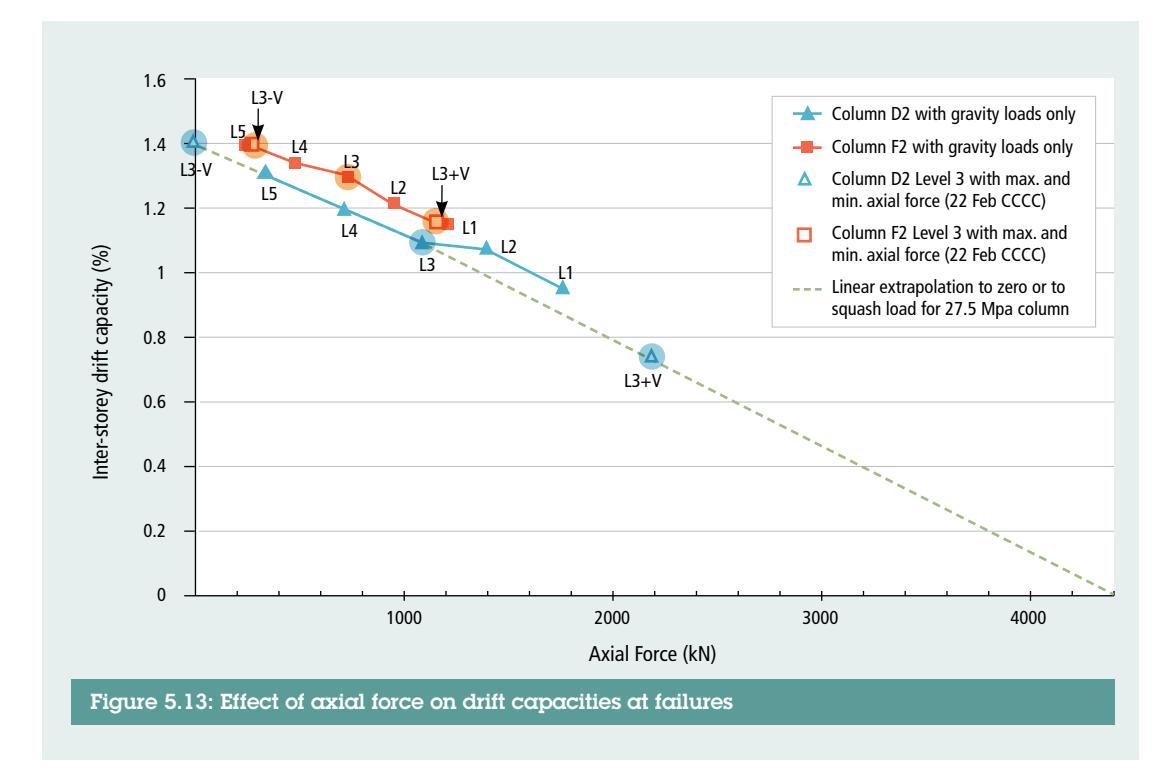
The vertical accelerations measured in the 22 February 2011 aftershock were exceptionally high and may have contributed significantly to vertical forces and columns and walls. The extent of this contribution is generally difficult to quantify, but analyses of the CTV Building indicated that vertical accelerations could have doubled the vertical forces in some critical, heavily loaded columns and this may have reduced the capacity of those columns to sustain lateral displacements by up to 40%, depending on concrete strength. If concrete strength in those critical columns had been less that the values that the analyses were based on, the displacement capacity would have been further reduced.

The highlighted markers on each plot in Figure 5.13 show the situation for two columns at Level 3. The middle highlighted marker shows the axial force and drift capacity without earthquake effects. The highlighted markers to the right and left show the effects of vertical earthquakes, reducing (left mark), or increasing (right mark) the column axial force (compression). It can be seen that in these examples, the effect on drift capacity is significant, ranging up to more than 30%.

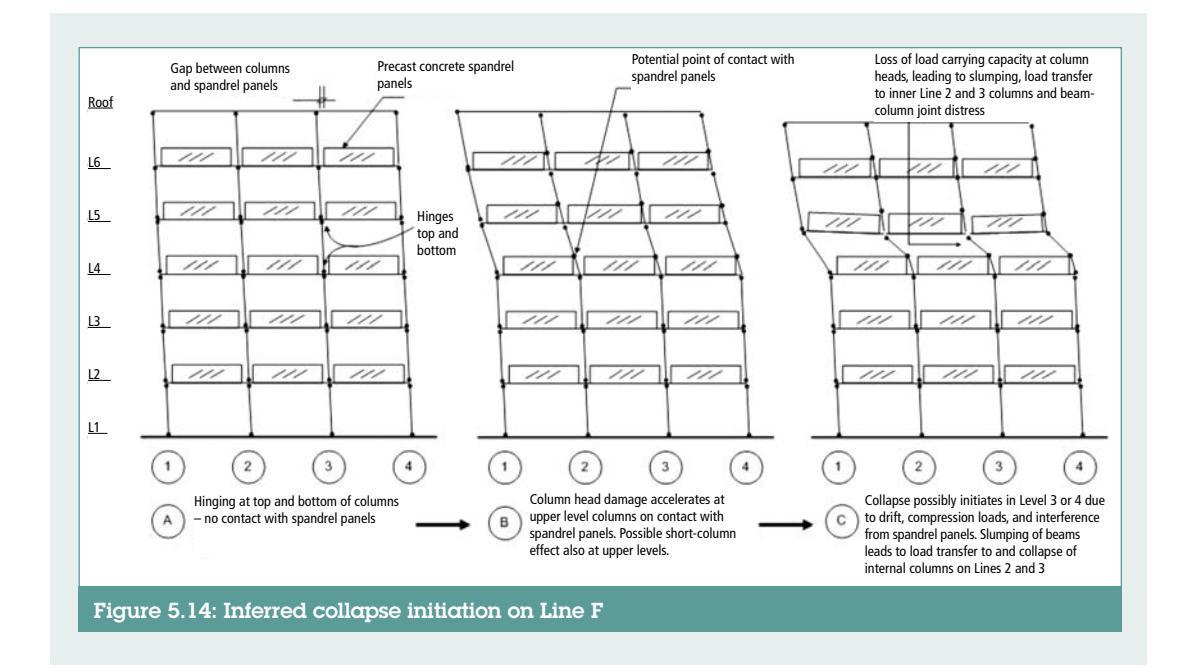
Figure 5.14 shows the situation for this scenario with no spandrel interaction (A) and with spandrel interaction (B and C). Figure 5.16 illustrates the case of failure of ground floor columns on Line D for this scenario and the subsequent collapse of the floor slabs and frames for this inferred collapse sequence. Figure 5.15 shows the case along Line 2 of the scenario involving initiation on Line F.

Concrete strengths that were lower than the average used in the analyses would have reduced the load capacities of critical columns. Vertical accelerations from the ground motions may have added to the demands on columns and reduced their capacities to tolerate lateral displacement. The lack of symmetry of the lateral load-resisting elements is likely to have placed further demands on the critical columns by causing the building to twist and displacements to be larger than expected. Failure of diaphragm connections between floors and the north core walls, if it occurred prior to collapse initiating elsewhere, may have resulted in additional displacement demands on the critical columns.

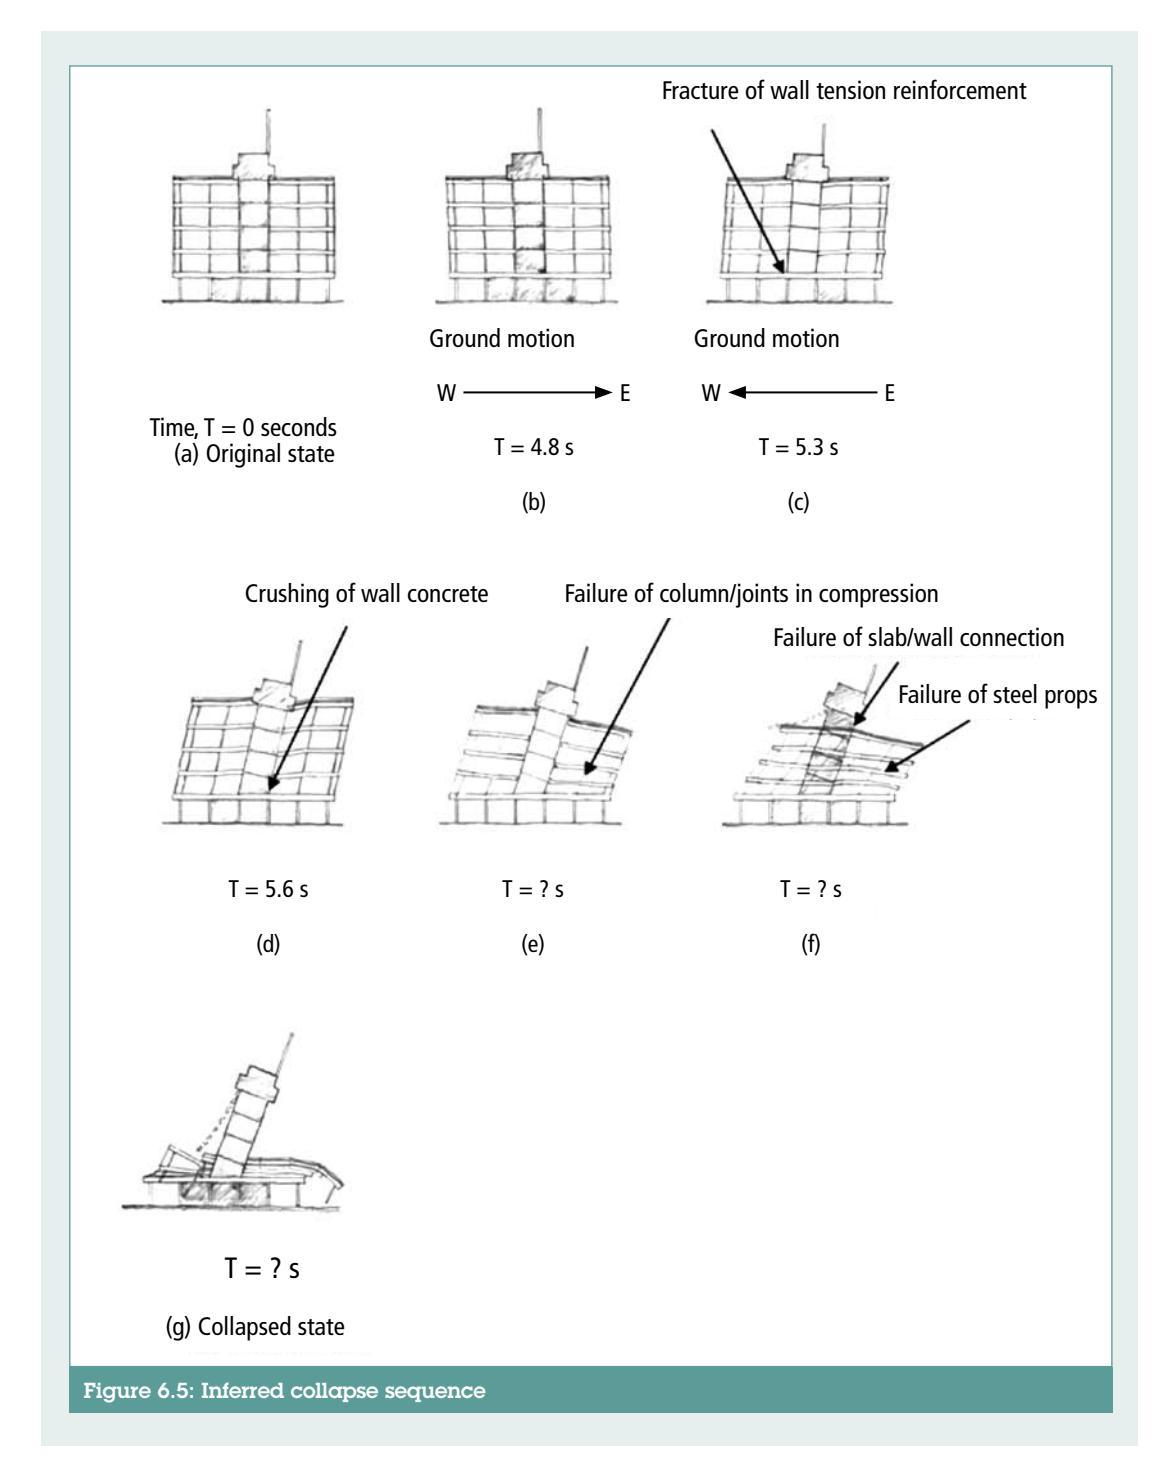
Analyses and site observations indicate the following sequence of collapse (refer to Figure 6.5). The PGC Building collapsed when the east and west reinforced concrete walls of the core between Level 1 and Level 2 failed during the aftershock. The west wall yielded in vertical tension, and then the east wall failed catastrophically in vertical compression. The ground floor structure stayed intact, virtually undamaged as it was significantly stronger and stiffer than the structure above. Torsional response (ie twisting of the building about a vertical axis) was not a significant factor. Once the west wall had failed, the horizontal deflections to the east increased markedly. The perimeter columns and/ or joints between the columns and the beams, and the connections between the floor slabs and the shear-core failed consequentially at some levels, causing the floors to collapse.

The reason the PGC Building collapsed was that the shaking experienced in the east-west direction was almost certainly several times more intense than the capacity of the structure to resist it. In addition, the connections between the floors and the shear-core, and between the perimeter beams and columns, were not designed to take the distortions associated with the core collapse. Neither foundation instability nor liquefaction was found to be a factor in the collapse.

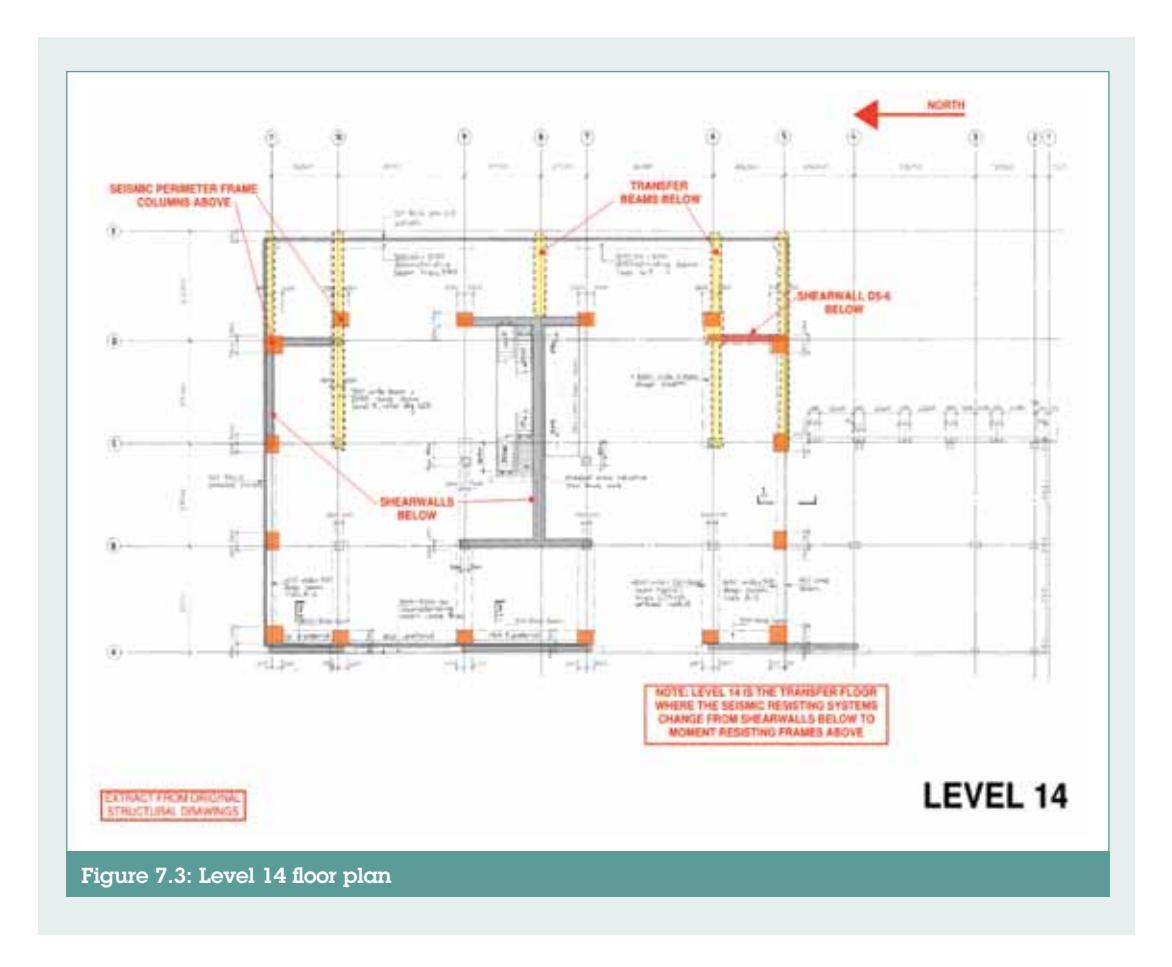
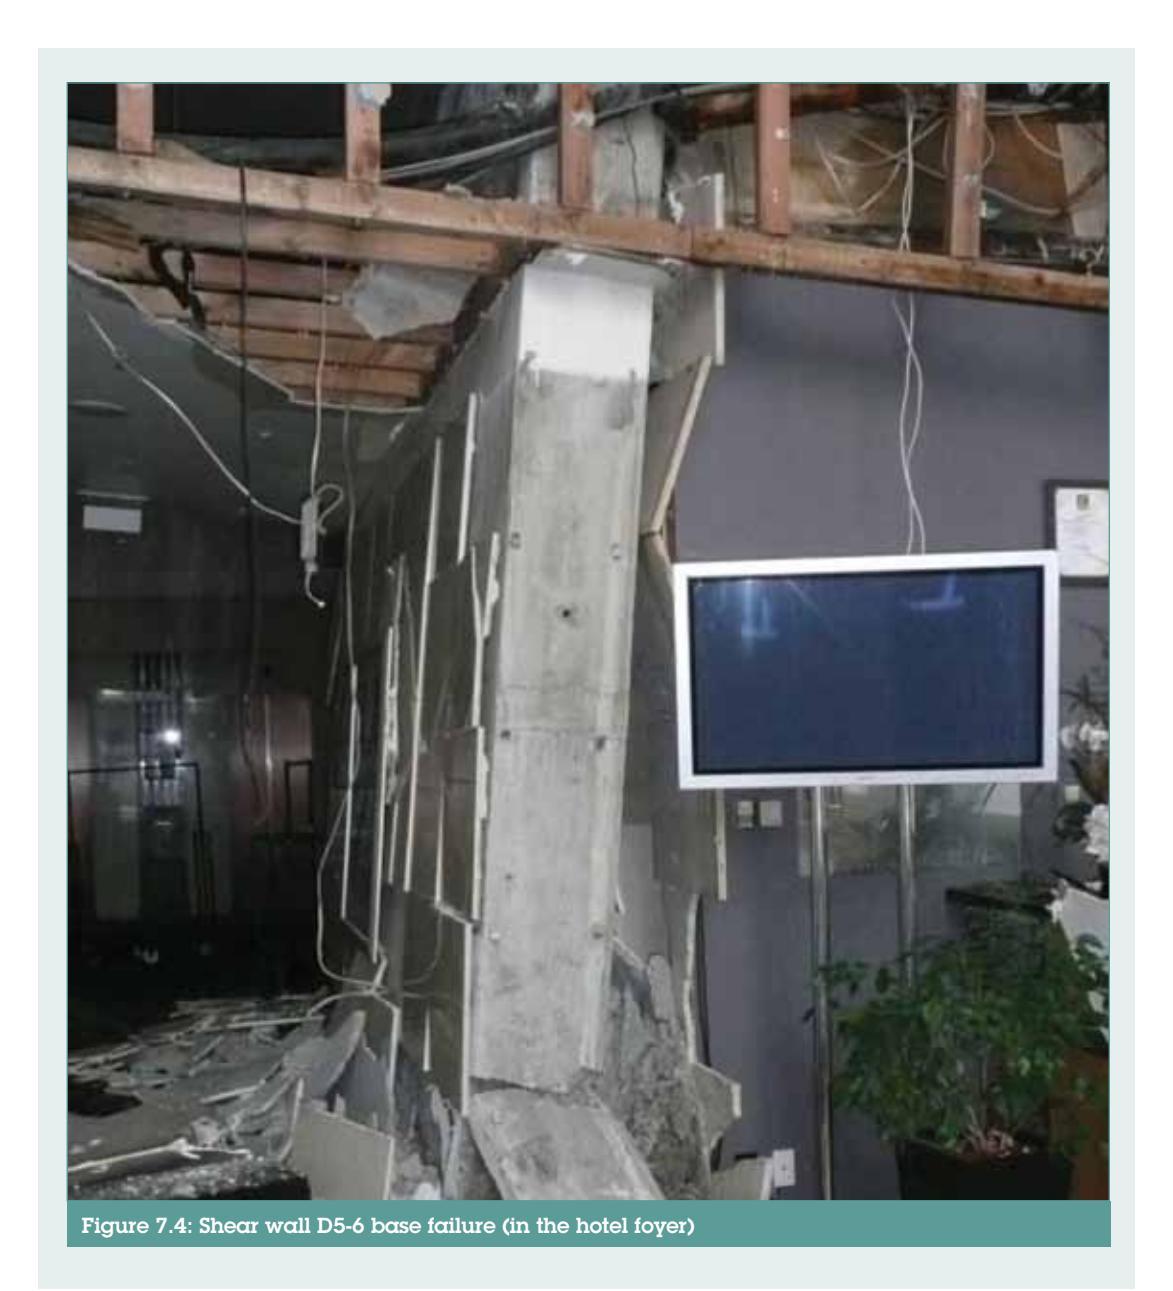
During the approximate 12 seconds of intense shaking that occurred in the 22 February 2011 aftershock, the Hotel Grand Chancellor Building suffered a major structural failure with the brittle rupture of a shear wall (D5-6, refer to Figure 7.3) in the south-east corner of the building. This shear wall provided vertical support for approximately one-eighth of the building's mass and was also expected to carry a portion of lateral earthquake loads. Damage to the base of the shear wall is shown in the photograph in Figure 7.4.

As a result of the wall failure, the south-east corner of the building dropped by approximately 800mm and developed an accompanying horizontal lean of approximately 1300mm at the top of the building. This major movement induced other damage including column failure at the underside of the podium, beam yielding, stair collapse and pre-cast panel dislodgement. The collapse of the stairs, in particular, was dependent on the wall failure. Other more minor structural damage was consistent with what may have been expected in a well-performing reinforced concrete structure in a seismic event of this nature.

The 22 February 2011 aftershock induced actions within the wall that exceeded its capacity and caused failure and partial collapse.

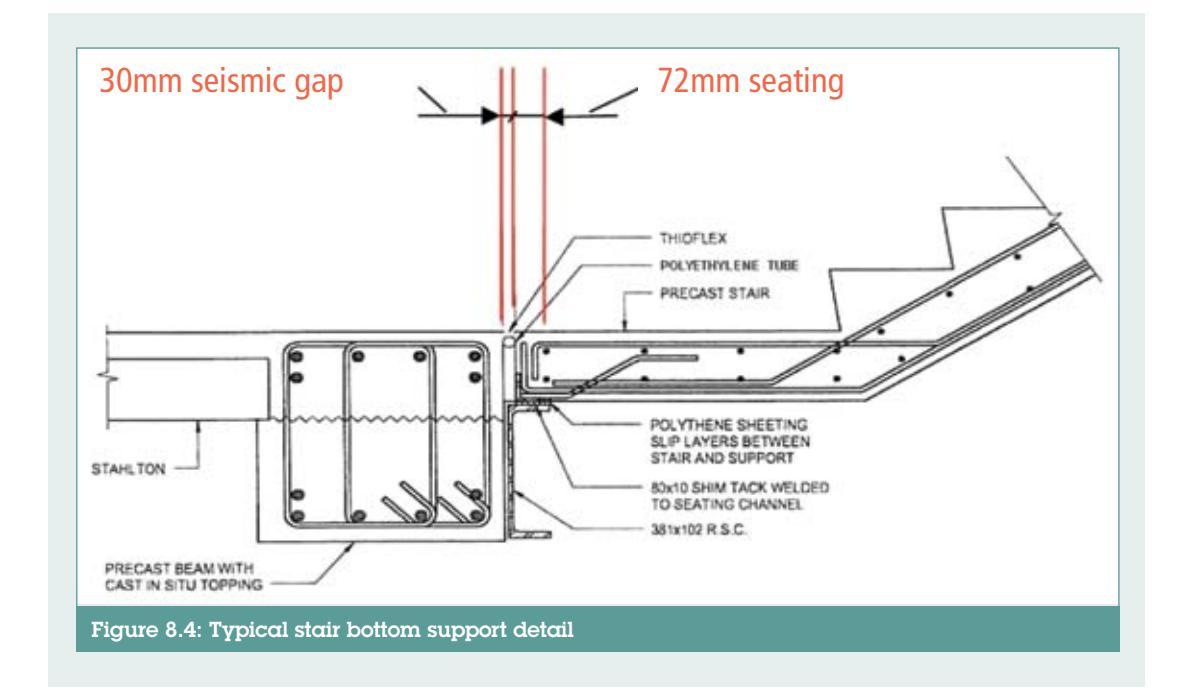
The stairs are orientated diagonally within the tower in a north-east/south-west direction. The majority of the stair flights were pre-cast units cast into the landing at their upper ends, and seated on a steel channel at their lower ends which, in an earthquake, allowed the lower end to slide within limits. This provided a horizontal gap specified at 30mm wide for the closing cycle and 72mm for opening (refer to Figure 8.4).

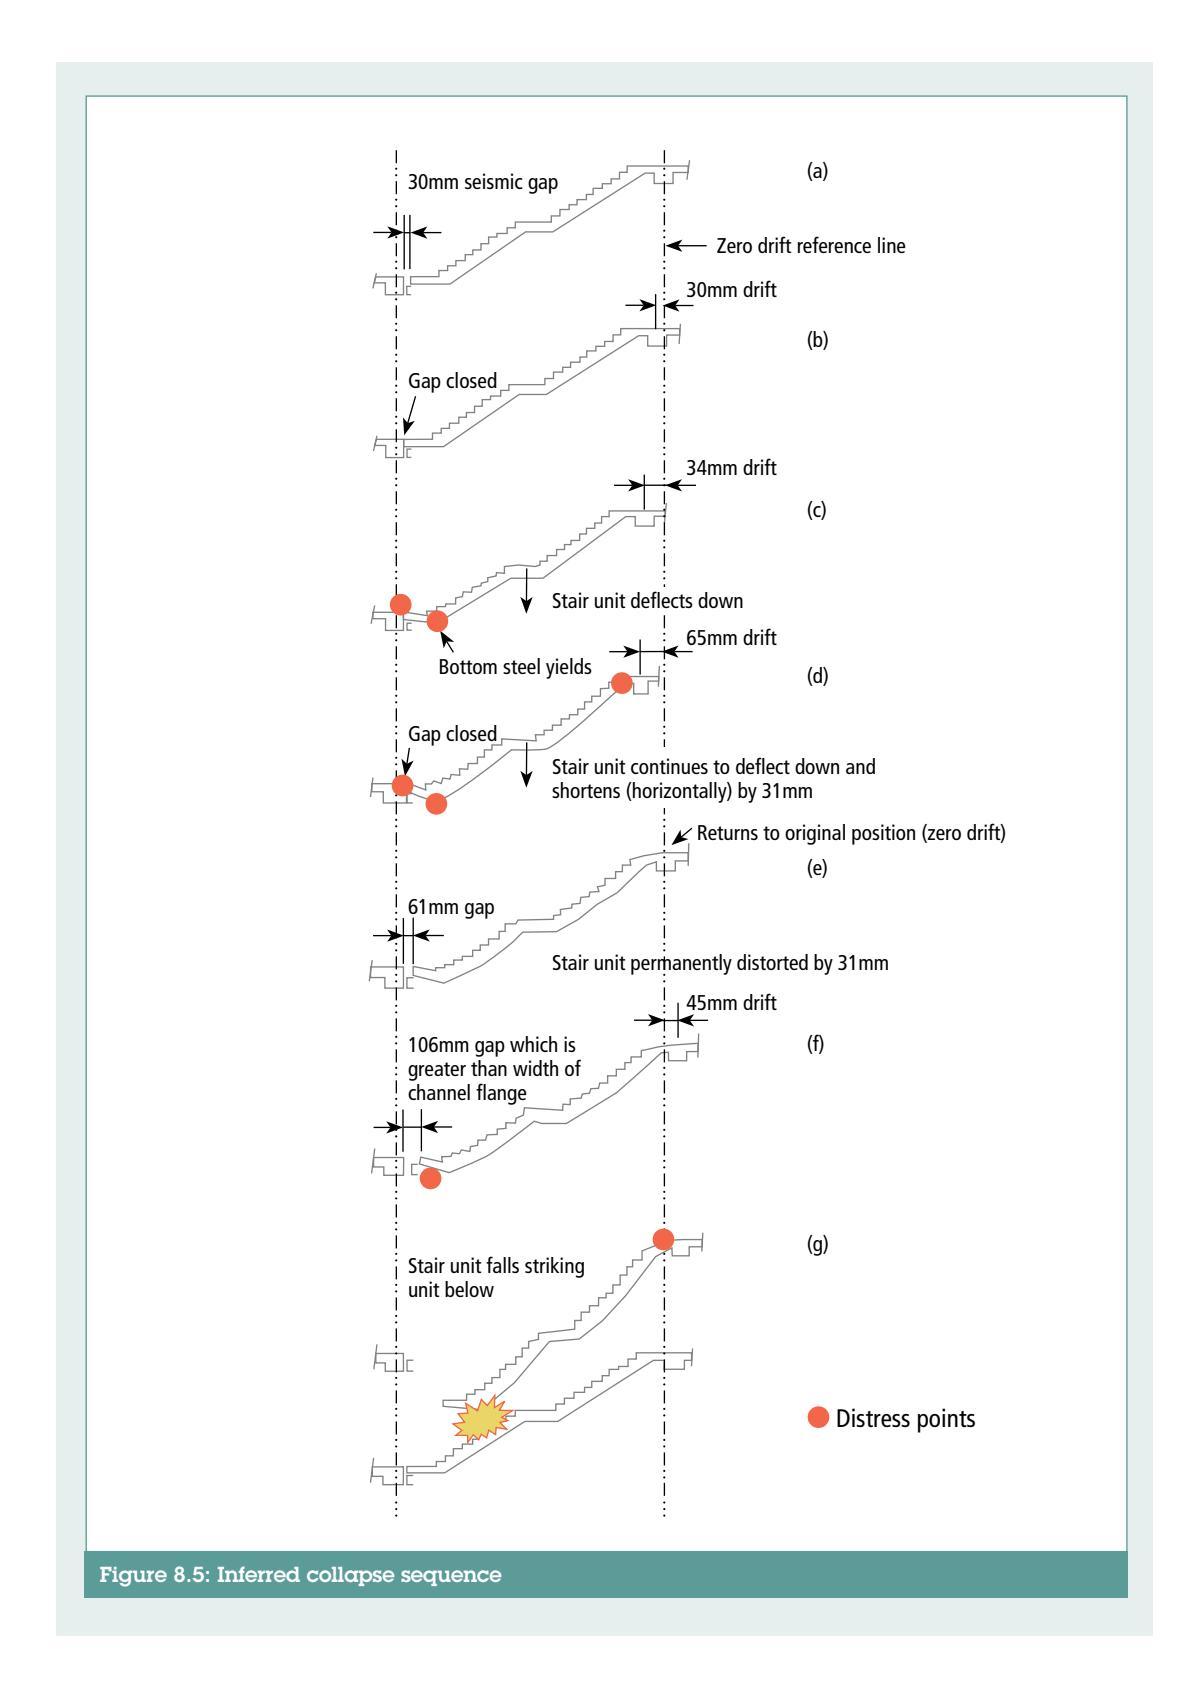
- The effective horizontal length of the stair unit was shortened when struck by the stair unit above, after the unit above lost its seating and rotated downwards about its upper landing. The consequent V-shaped lower unit would then have dragged its lower landing off its seat.

- A free-falling stair unit simply impacted the still-intact unit, causing it to fail catastrophically and fall.
- Construction tolerances and the possibility that the seismic gap at the lower stair support had been filled (with debris, mortar or polystyrene), would have reduced the level of building horizontal displacement required to fail the stair. Even though the stair separation gaps as designed met the code of the day, analyses indicate that the collapse would have occurred even if the joints had been fully free to move.

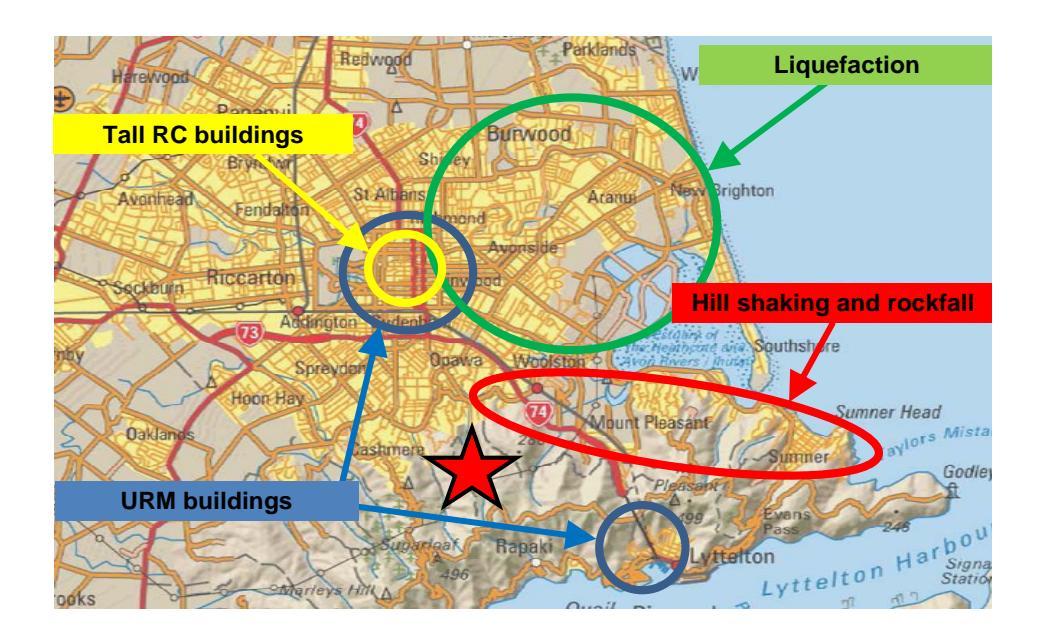
Figure 1: Overview of the 22nd Feb 2011 Christchurch earthquake effects on built environment (modified after NZCS/NZSEE/TDS Seminars on Performance of Buildings after 22 Feb Earthquake).

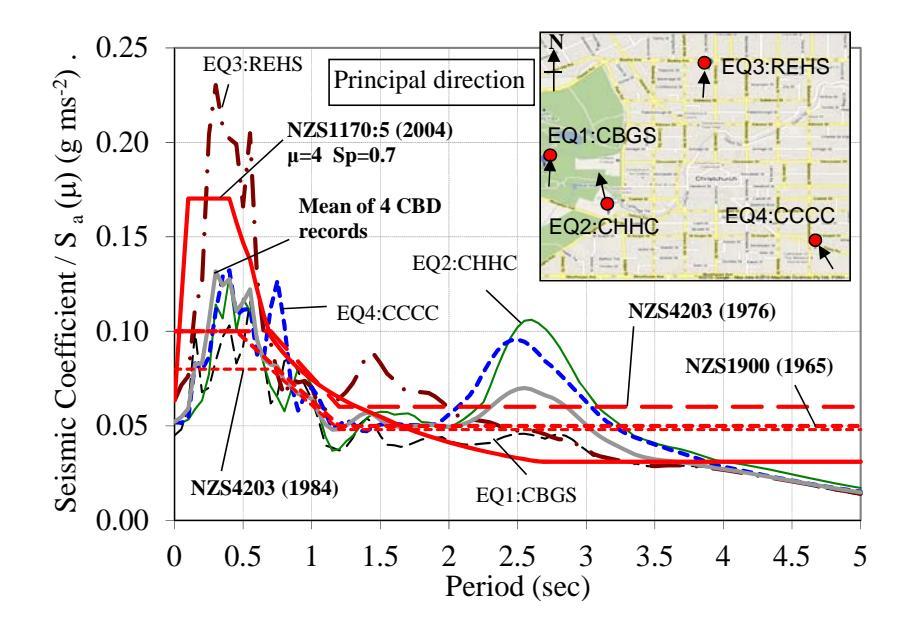
Figure 7. 4 September 2010 M_w 7.1 earthquake: pseudo-inelastic acceleration response spectra (principal horizontal direction) in the Christchurch CBD and the NZS1170:5 design spectra (red solid) for Christchurch (soil class D, R=35km, μ=4 and Sp=0.7).

Based on Figure 7, the seismic demands (in acceleration/forces) were close to or below the NZS1170:5 (2004) design level (minimum expected capacity) for very recently designed structures with periods between 0.5s and 2.0s. At lower periods (<0.5s), the seismic demands (in acceleration/forces) were generally lesser than the NZS1170.5 (2004) design spectra but exceeded the older codes design spectra. In the period range (0.6s<Ti<1.6s), corresponding to the typical mid-rise RC building in the CBD, the NZS4203 (1976) and NZS1170:5 (2005) specify comparable seismic coefficients, while NZS4203 (1984) and NZS1900 (1965) requirements are approximately 33% lower. The higher spectral ordinate demands for longer periods (Ti>2.0s) suggests that high rise buildings designed to the NZS1170:5 (2004) may have sustained significant seismic demand.

Interestingly, the older NZS4203 (1976 and 1984) and NZS1900 seismic coefficients are generally lower in the short periods (T₁<0.6s) and higher in the long periods (T₁>1.4s-1.6s) when compared with the NZS1170.5 design spectra for a similarly ductile reinforced concrete frame. It should be noted that while the seismic design acceleration/forces are discussed herein, the ductile detailing and other design aspects have significantly improved over time, resulting in a higher likelihood to achieve the assumed ductility (capacity to displace in the inelastic range) implied in the loading standards.
