EXPERT PANEL REPORT

Structural Performance of Christchurch CBD Buildings in the 22 February 2011 Aftershock

February 2012

Report of an Expert Panel appointed by the New Zealand Department of Building and Housing

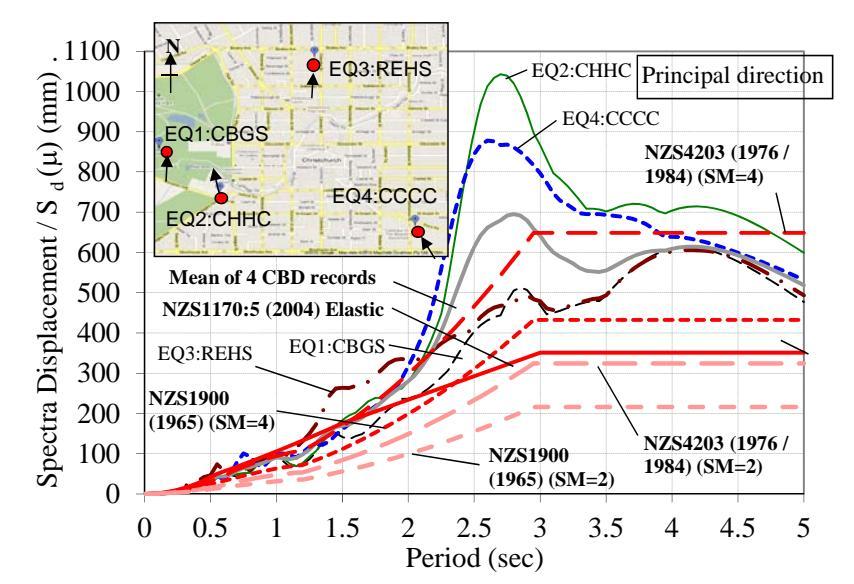
Figure 8. 4 September 2010 Mw 7.1 earthquake: Elastic displacement response spectra and 5-% damped elastic design displacement spectra.

The seismic displacement demand implied by the elastic displacement spectra shown in Figure 8, also suggests that the deformation demands at lower building periods ($T_1 < 1.5s-2.0s$) were generally low. For instance, the displacement demand, S_d of 90mm at effective/elastic period of 1.0s, suggests an interstorey drift (relative displacement between two consecutive storeys divided by the height of the storey

Significant displacement demand can be observed at the long period range ($T_1 > 2.5s$), suggesting some higher level of deformation demands for high-rise buildings with relatively flexible system (e.g. moment-resisting frames). Incidentally, from a displacement-based design and assessment point of view, it seems that the NZS1170:5 (2004) design spectra, being derived as a pseudo-displacement spectra generated by the acceleration spectra, do not adequately capture the long period demand.

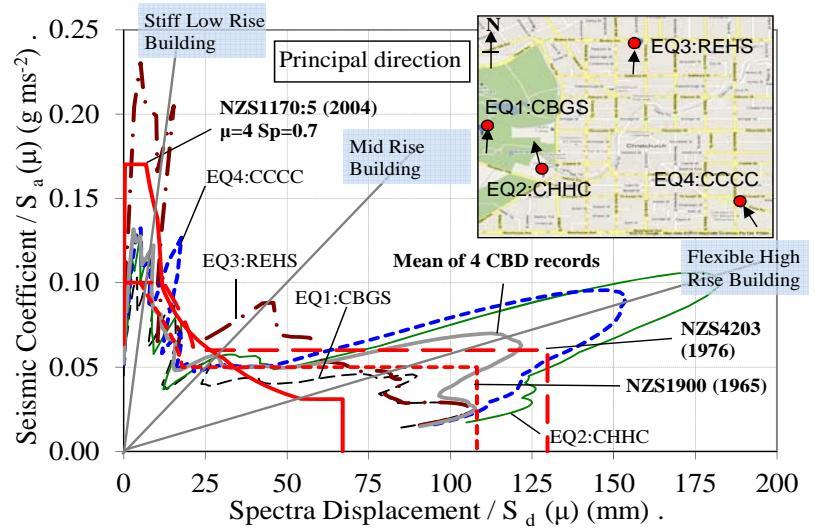
Figure 9. 4 September 2010 M_w 7.1 earthquake: Inelastic Acceleration-Displacement Response Spectrum (ADRS) (principal horizontal direction) for the four Christchurch CBD records and the NZS1170:5 design spectra (red solid) for Christchurch (soil class D, R=35km, μ =4 and Sp=0.7).

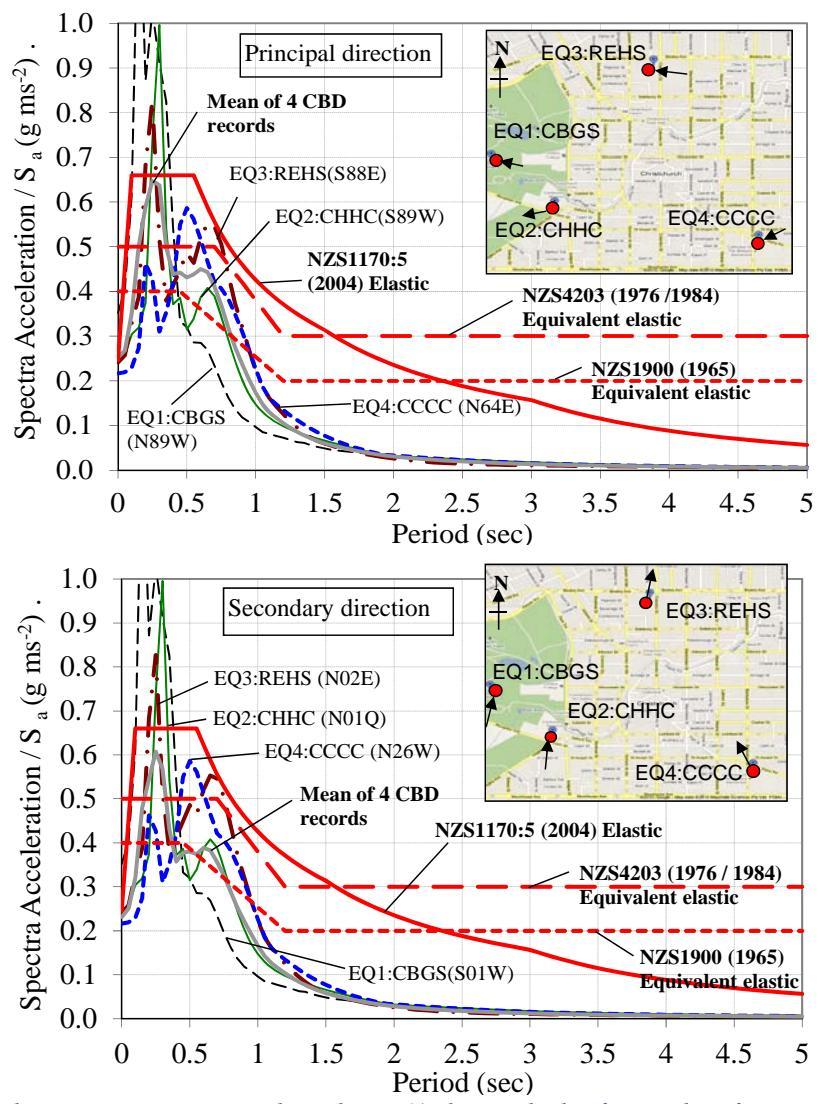
Figure 10: 26 December 2010 M_w 4.9 earthquake: 5%-damped elastic acceleration response spectra in the Christchurch CBD and the NZS1170:5 design spectra (red solid) for Christchurch (soil class D, R=20km): a) Principal horizontal direction; and b) Secondary horizontal direction.

In general, the level of seismic shaking of the 26 Dec earthquake appears from the spectra comparison to be limited to the short period structure (i.e. low rise stiff buildings). Severe shaking was likely to be experienced by buildings with less than 0.5s periods such as one to three storeys unreinforced masonry buildings. This is consistent with the observed damage in the Christchurch CBD. In other period ranges, the seismic shaking intensity decreased significantly at higher periods, as expected for a relatively low magnitude earthquake. The seismic intensity was also significantly attenuated outside the CBD area, with limited ground shaking acceleration recorded outside a 30km radius.

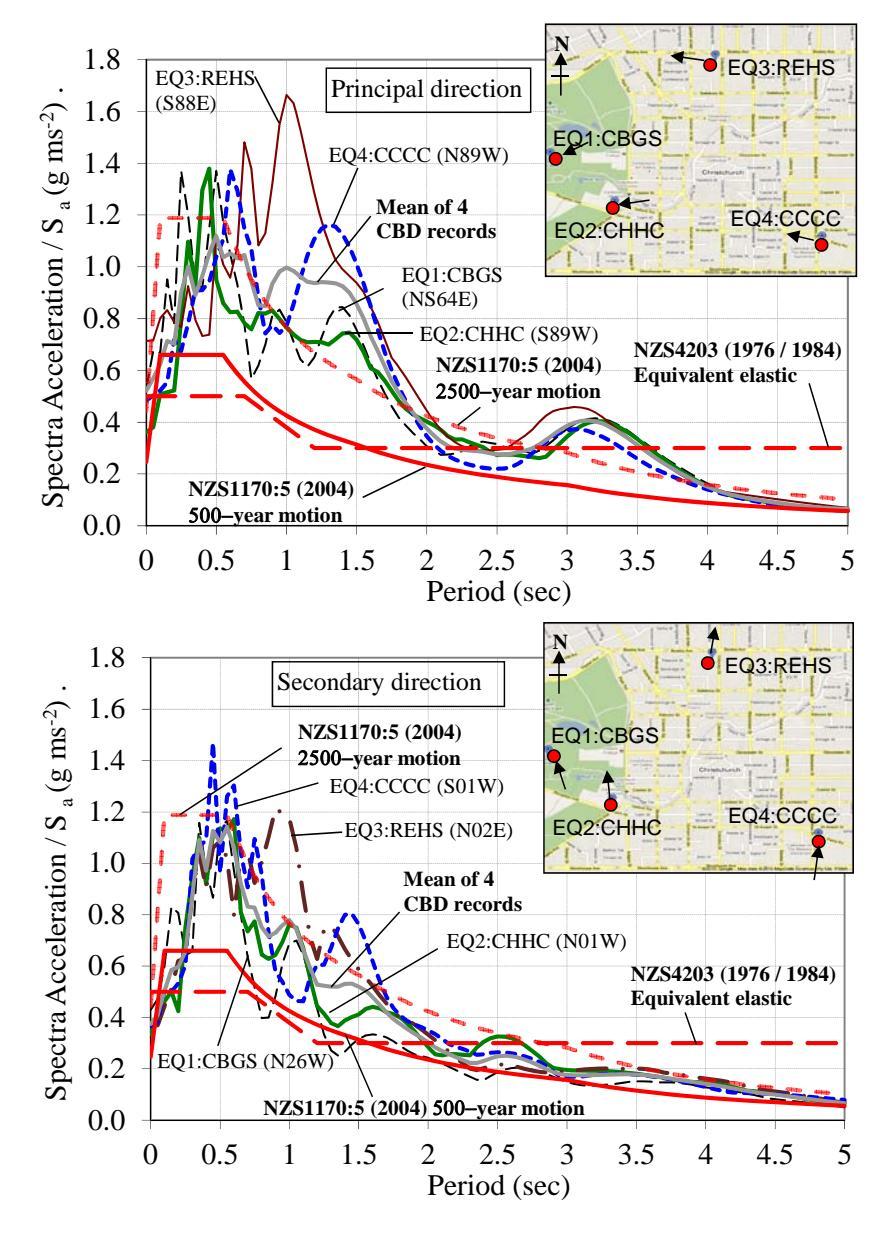
- In general, it can be noted that the seismic shaking in the Christchurch CBD <u>significantly exceeded</u> the 500-years design spectra, which is the typical design level in New Zealand (as in the rest of the word) for new buildings. The principal direction of shaking was of the predominantly East-West component. The East-West components were approximately 15-30% higher in the periods ranging from 0-2.4s, except for the period range of 0.35s-0.6s in which the North-South components were stronger;
- The East-West components matched or exceeded the New Zealand loading standard NZS1170:2004 (NZS1170, 2004) 2500-year motion in the period range of 0.5s-1.75s (approximately 5-20 storeys RC buildings).

It should furthermore be recalled that the existing NZS1170.5:2004 design spectra and the underlying probabilistic seismic hazard model do not (currently) consider any near-fault effects for Christchurch CBD as there was no known active fault within 20km of Christchurch CBD. The amplification of spectra acceleration in the 0.5s to 1.5s period range and the shift of the peak spectra acceleration 'plateau' is typically observed in ground motion records with forward directivity effects (Somerville, 2003, Somerville, 2005) Such features are included in the acceleration spectra shape in some major seismic codes around the world and could provide valuable suggestions for similar implementation in the next revision of the NZS1170:5 loading standard. In addition, the soft-soil site amplification observed in the response spectra is also significantly higher than typical measurement for similar

Figure 11: 22 February 2011 M_w 6.2 earthquake: Elastic acceleration response spectra (5%-damped) in the Christchurch CBD, after the Feb 22 event, and the NZS1170:2004 design spectra (red solid) for Christchurch (soil class D, R=20km): a) Principal horizontal direction (generally East-West component); b) Secondary horizontal direction (generally South-North component).

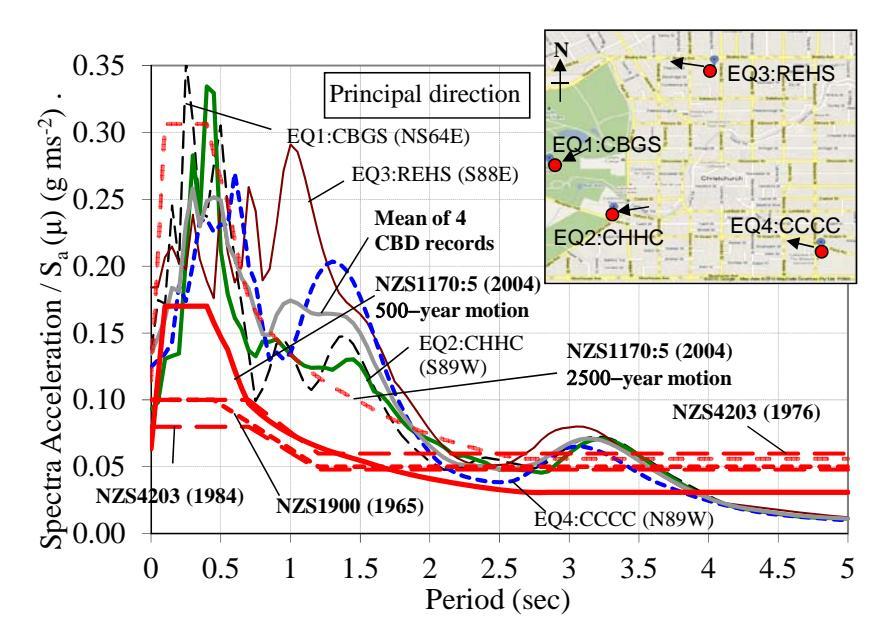
An immediate observation is that the 'pseudo-inelastic' acceleration response spectra of all the principal horizontal records from the CBD recording station well exceeded the 500-years return period design spectra for most period range. As mentioned, the 500-years return period design level is the typical seismic design loading for normal structures as per NZS1170.5:2004. With a pseudo-inelastic acceleration demand up to two to three times the design level for a ductile (μ =4 and Sp=0.7) structure, it is expected that many of the buildings in Christchurch CBD will suffer significant damage.

Figure 12. 22 February 2011 M_w 6.2 earthquake: pseudo-inelastic acceleration response spectra (principal horizontal direction) in the Christchurch CBD and the NZS1170:5 design spectra (red solid) for Christchurch (soil class D, R=35km, μ =4 and S_P=0.7).

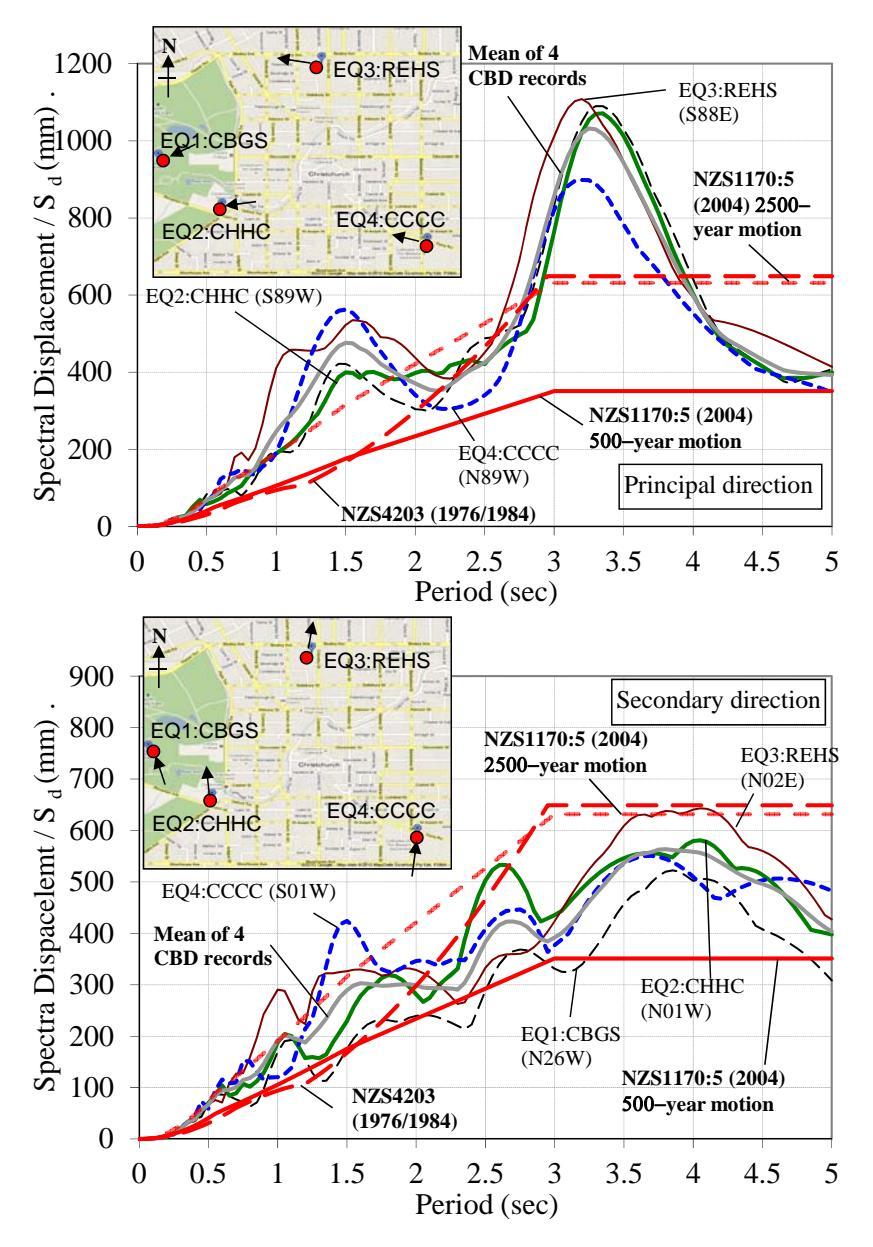
- At all period ranges, the principal direction horizontal shaking was higher than the 500-years design displacement spectra.
- In the principal direction, there were significant displacement demands between 1.0s to 1.8s and 2.9s to 3.8s. This suggests that in-elastically responding RC buildings between 5 to 10 storeys and 15 to 20 storeys would have had significant displacement demands and by extension, possibly significant damage. The principal direction motion far exceeded the NZS1170:2004 (NZS1170, 2004) 2500-year motion (Maximum Credible Event, MCE) design spectra at these two period ranges.

- The two 'amplification lumps' observed in the principal direction motion were not apparent in the secondary horizontal direction motions.
- The spectral displacement demands in the secondary direction were significantly lower when compared to the principal direction. However, the spectral displacement demand in the weaker secondary direction was still higher than the NZS1170:2004 500-years motion pseudo-displacement design spectra.

Figure 13: 22 February 2011 M_w 6.2 earthquake: 5%-damped elastic displacement response spectra of four Christchurch CBD records and the NZS1170:2004 design spectra (red solid) for Christchurch (soil class D, R=20km): a) Principal horizontal direction (generally East-West component); b) Secondary horizontal direction (generally South-North component).

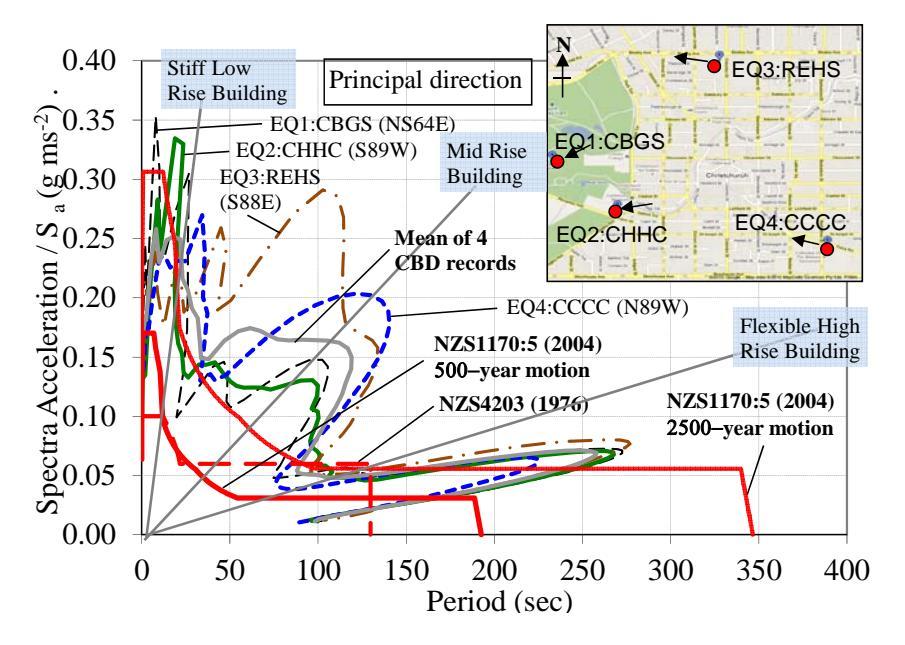
Figure 14. 22 February 2011 M_w 6.2 earthquake: Inelastic Acceleration-Displacement Response Spectrum (ADRS) (principal horizontal direction) for the four Christchurch CBD records and the NZS1170:5 design spectra (red solid) for Christchurch (soil class D, R=20km, μ =3 and S_P=0.7).

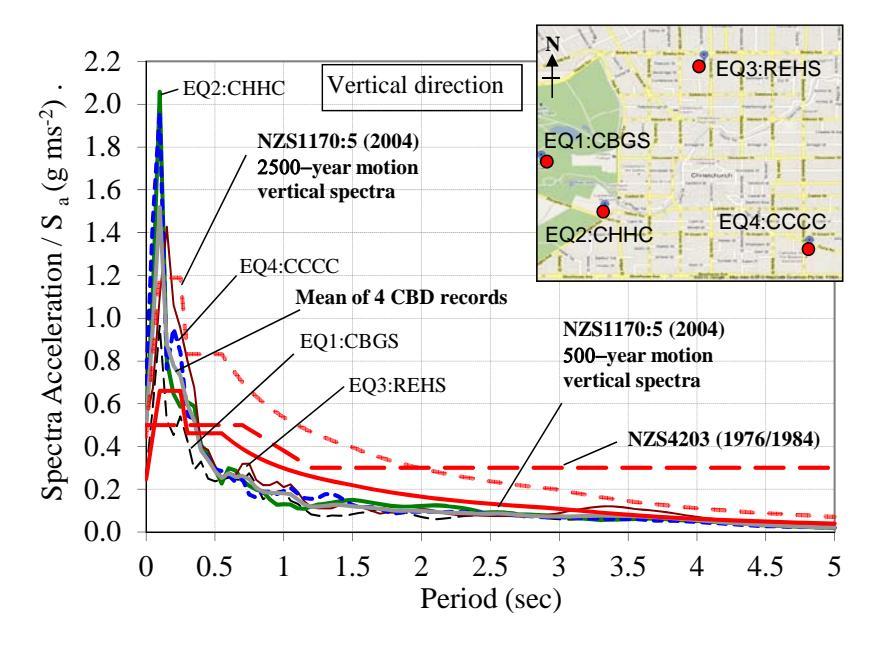
As it is difficult to determine the vertical stiffness of structures, it is hard to correlate the vertical acceleration demand to structural vertical response spectral demand. At very short period range (0.05s < T < 0.25s), the vertical response spectra greatly exceeded the expected 2500-year motion vertical spectra (according to NZS1170:2004). A very high vertical acceleration can potentially amplify compression-loading on columns and walls, triggering axially dominated brittle failure mechanisms,

induce higher gravity/seismic load on transfer elements and vertically unrestrained elements (e.g. simply-supported stair landing). Further research is required to quantify these effects.

Figure 15: 22 February 2011 M_w 6.2 earthquake: 5%-damped elastic vertical acceleration response spectra in the Christchurch CBD and the NZS1170:2004 design spectra (red solid) for Christchurch (soil class D, R=10km).

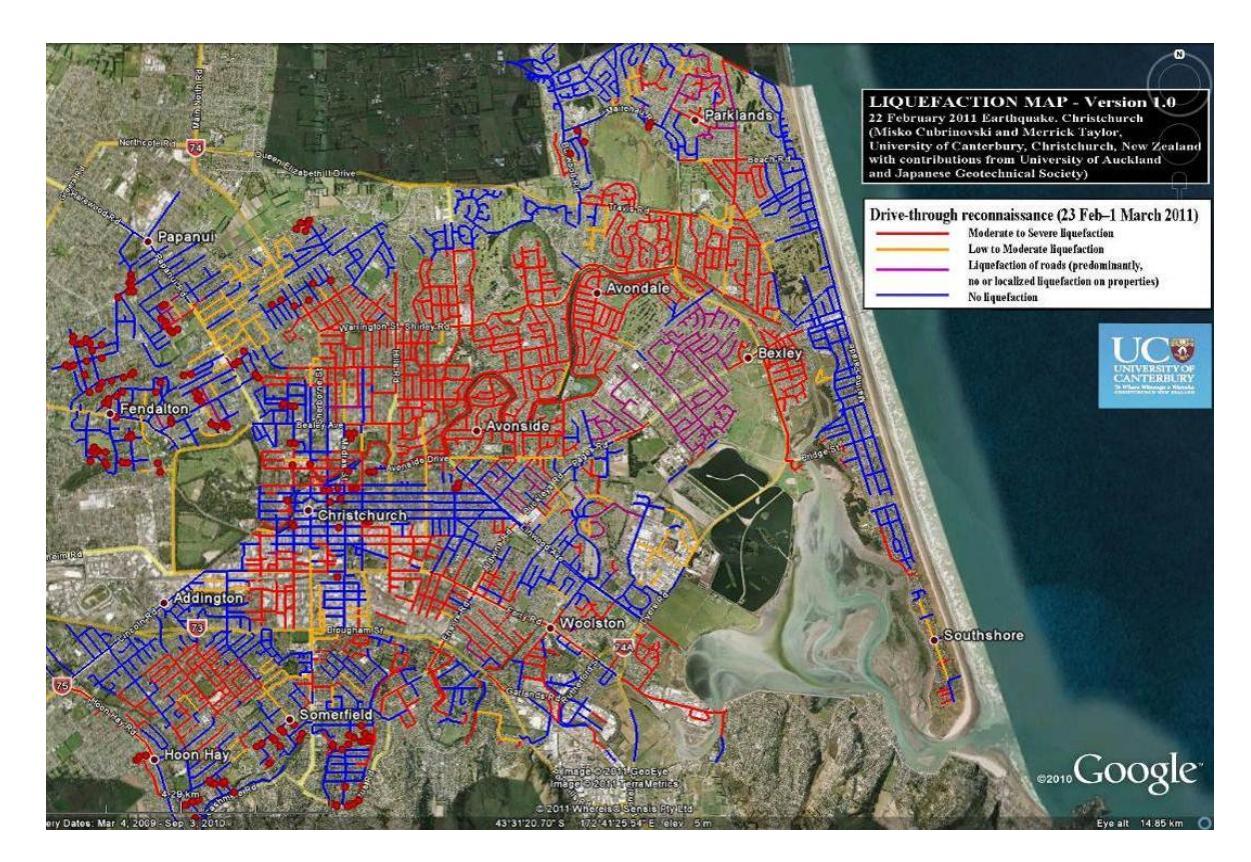
In the 22nd Feb 2011 6.2M_w Christchurch earthquake, many of the eastern Christchurch suburbs again had severe liquefaction and lateral spreading land damage. Figure 16 shows a preliminary liquefactiondamage map from the 22nd February 2011 earthquake. In comparison to the September earthquake, Christchurch City Council has removed 322000 tonnes of silt (as of 10 March 2011). Within the Christchurch CBD, severe liquefaction and moderate lateral spreading was observed in several concentrated zones: a) areas along the Avon riverbanks e.g. Oxford and Cambridge Terraces; b) segments of Kilmore Street; c) segments of Armagh Street; d) segments of the North-East of Madras, Manchester and Salisbury Streets and e) segments of Fitzgerald and Moorhouse Avenues. Interestingly, many of the liquefaction-affected zones were former Avon River tributaries, as suggested by the 1850s Christchurch Map (Figure 17). Figure 18 and Figure 19 show severe liquefaction damage in the eastern suburbs and in the CBD area, respectively.

Figure 16: Liquefaction damage map around Christchurch city (courtesy of M. Cubrinovski and M. Taylor, source NZSEE Clearinghouse).

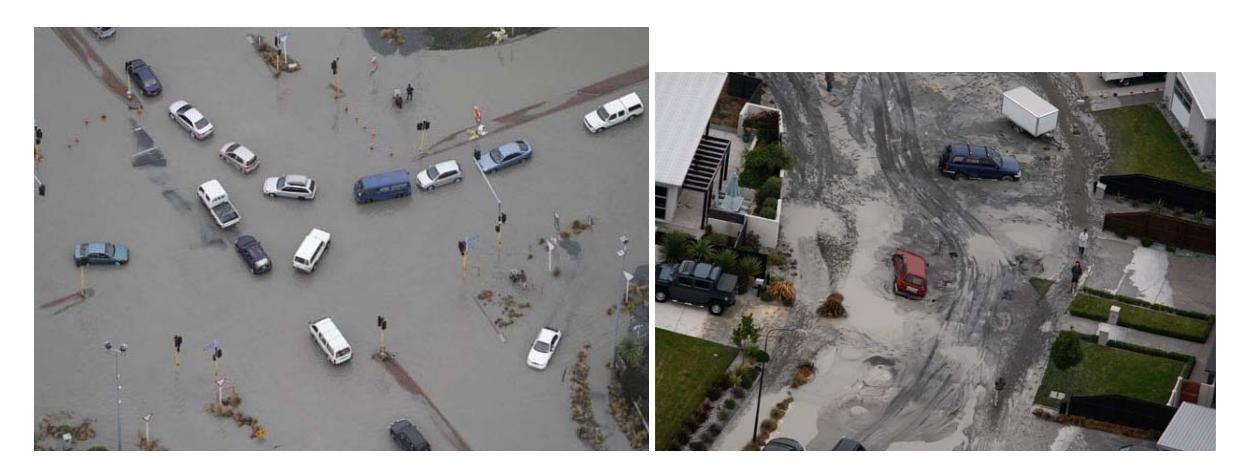
Figure 18: Widespread and severe liquefaction and temporary flooding in the eastern Christchurch suburbs

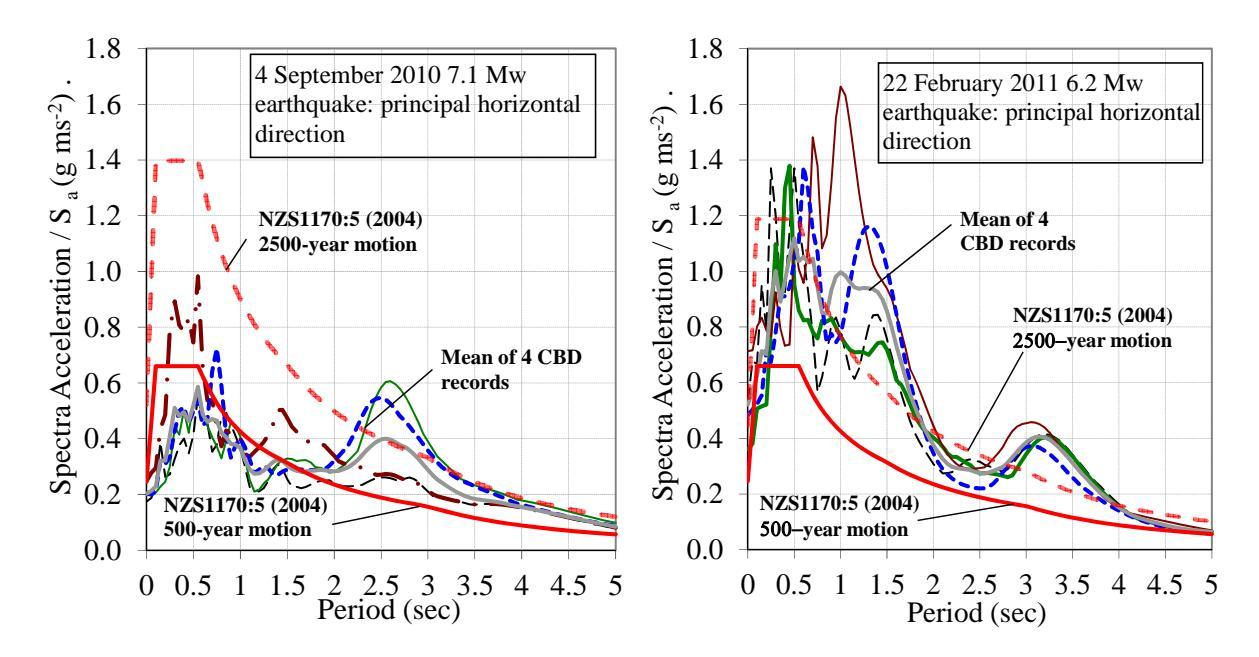
Figure 21 shows a direct comparison of the seismic response spectra of the 4 September 2010 and 22 February 2011 earthquakes. It can be directly observed that the seismic shaking intensity in the 22 February event greatly exceeded the 4 September event for building periods up to 2.0s and building periods between 3.0s to 4.0s.

Figure 21: Principal horizontal direction elastic acceleration response spectra (5%-damped) in the Christchurch CBD and the NZS1170:2004 design spectra (red solid) for Christchurch (soil class D, R=20km): a) 4 September 2010 Mw 7.1 earthquake; b) 22 February 2011 Mw 6.2 earthquake.

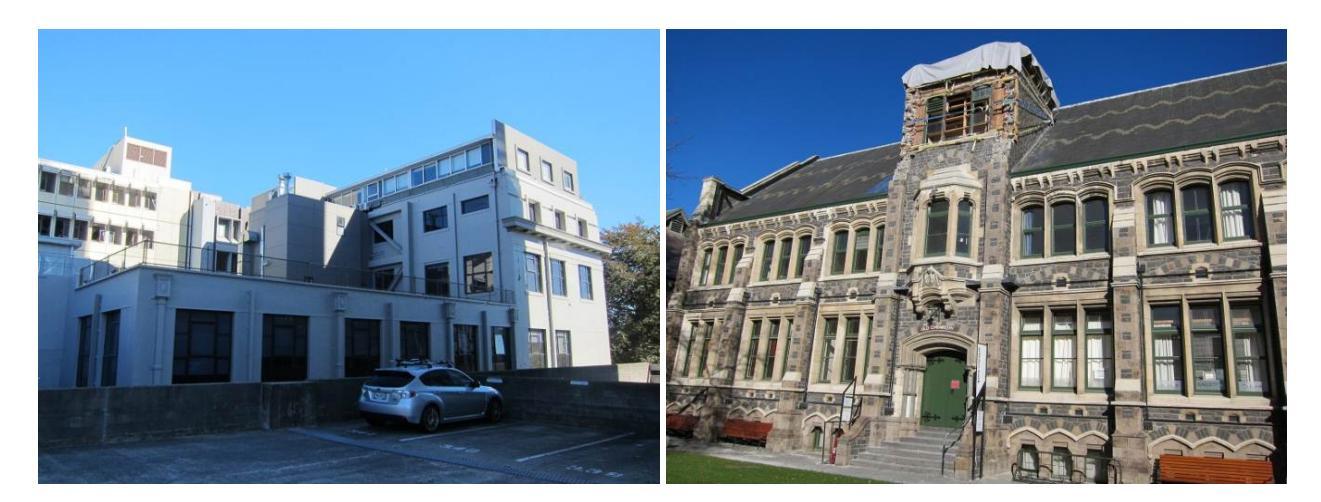
Figure 31: Good performance of seismic retrofitted unreinforced masonry and brick buildings: a) Public Trust Building: additional external steel braces and internal RC walls; b) Art Centre's Old Chemistry Building: external horizontal and vertical post-tensioning, with closely spaced tie-in rose anchors

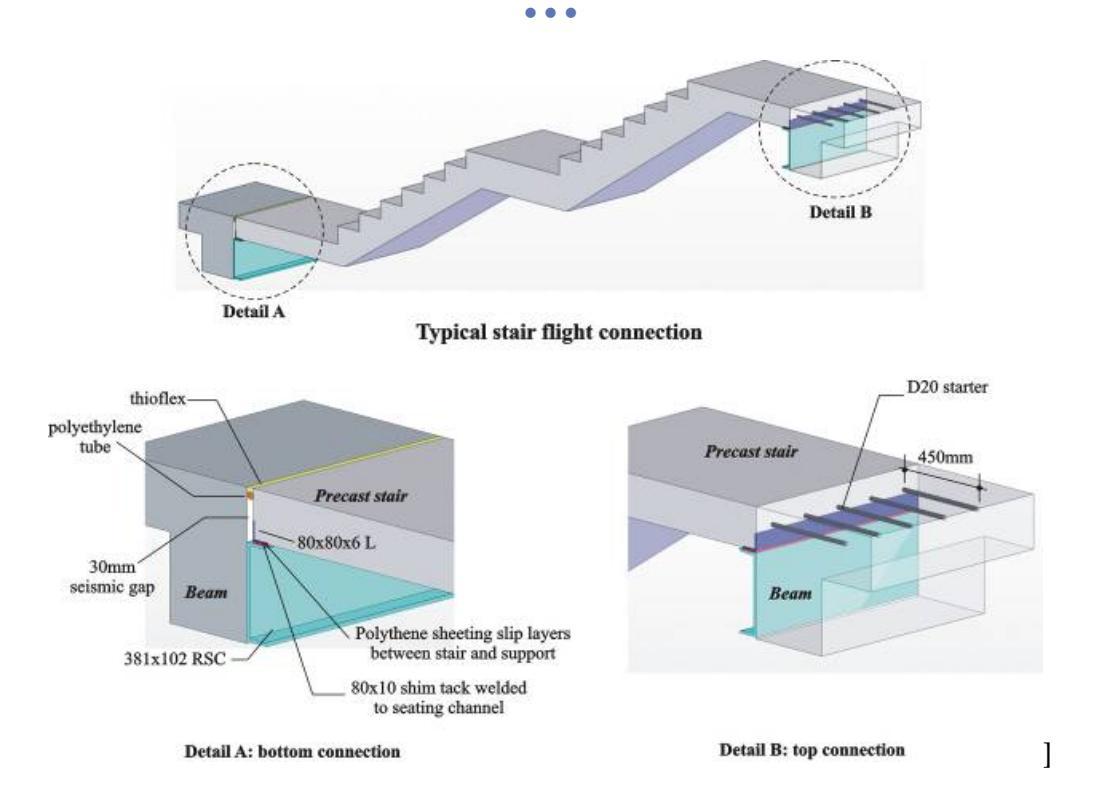
Type A aims to isolate the staircases from the lateral system, thus preventing or minimizing interaction between stairwell system and the surrounding structure. The Type A details require sufficient sliding gap at the free landing in order to allow for the displacement demand imposed by the earthquake. If this gap is insufficient or accidentally or erroneously grouted, the staircases are subjected to unexpected compression forces (that it is likely not designed for) or the staircase might be completely unseated (pulled away from the support). The damage observed in the earthquake indicates that the design displacement limits for the staircases were generally inadequate, when compared to the seismic demand of the 22 Feb earthquake, to prevent such compression to occur.

Figure 51: Typical detailing of staircase- Type A - Partially pinned-slide bottom connection; cast-in-situ connection at top with longitudinal starter bars lapped at landing. (Photo is courtesy of Umut Akguzel).
